# Dam foundation design for the main dam at Nam Ngiep1 hydropower project in Laos

## ABSTRACT

A roller compacted concrete (RCC) gravity dam of 167 m height is under construction in Laos. Due to a folded zone in the geology of the right abutment, several weak horizontal layers are distributed below the river bed and these were considered to have potential to seriously impact the dam stability. In order to evaluate the mechanical properties and the distribution and formation of these weak layers, detailed geological investigations were instigated by conducting core drilling, rock property tests, X-ray diffraction (XRD) analysis and computed tomography (CT) scanning. Through a multiple-wedge stability analysis and finite element analysis (FEA), a shear key was designed to penetrate part of the weak layers and be incorporated into the dam body to improve the dam stability against sliding.

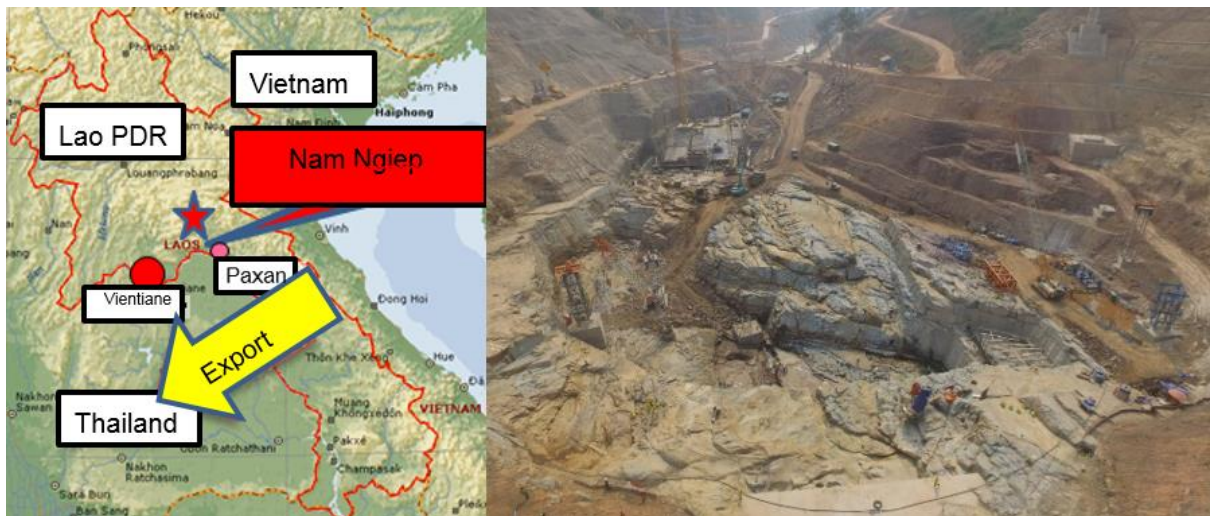
Figure 1. Location Map of Nam Ngiep 1 and Current Status of Excavation

The Nam Ngiep I Hydropower Project (NNP1) is a hydropower IPP (Independent Power Producer) invested in by the Kansai Electric Power Co., Inc. of Japan, the Electricity Generating Authority of Thailand and the Lao Holding State Enterprise of Lao PDR. It will be operated under a BOT scheme with assets being transferred to the Lao PDR after 27 years of operation. The project is located at the middle reaches of the Nam Ngiep River, a tributary of the Mekong River approximately 130 km northeast of Vientiane, the capital city, and will construct there two dams and two powerhouses. There will be a dam (height of 167 m) with a main powerhouse (273 MW) and a re-regulation dam (height of 17.7 m) with a re-regulation powerhouse (17 MW). The plan is to sell electricity from the main powerhouse to Thailand and that from the re-regulation powerhouse to the territory of the Lao PDR. Civil works are undertaken by Obayashi Corporation. The main dam is a gravity concrete (RCC) dam of a height of 167 m. Excavation of the dam foundation was completed in March 2016 and concrete placing work is now ongoing. This report will describe the design of the foundation of the main dam. Figure 1 shows the location of Nam Ngiep 1 and excavation works at the site.

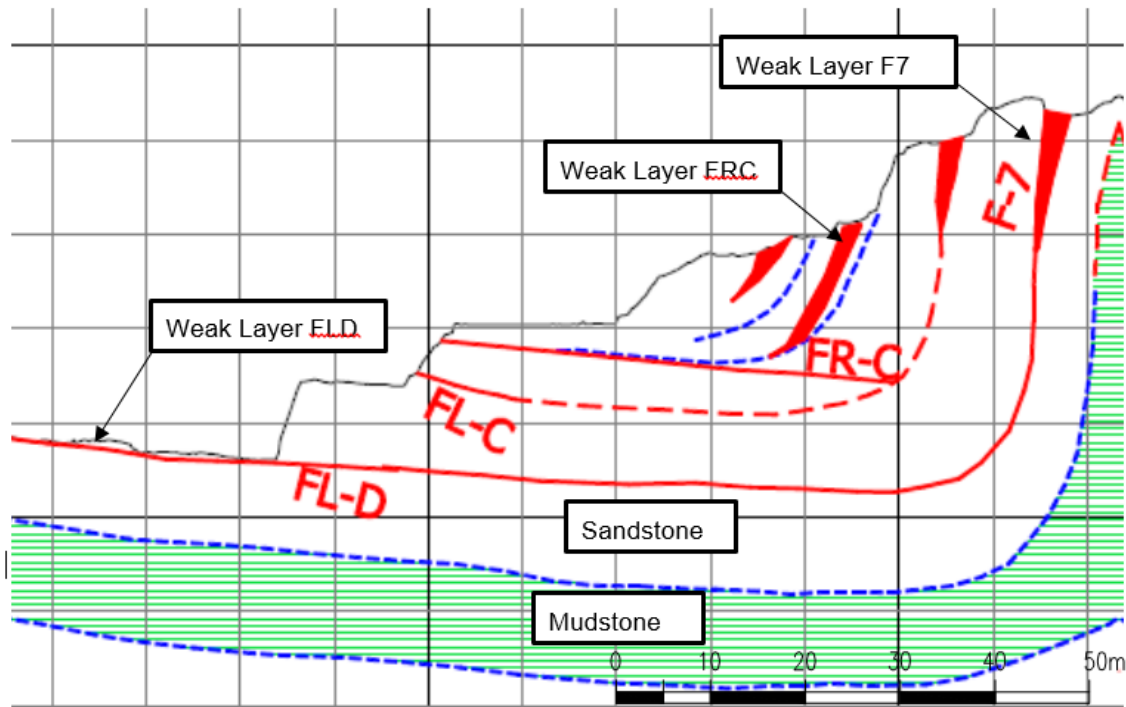
Figure 2 shows a geological cross-section of the river bed 25 m downstream of the dam axis. The geological features of the location of the dam are formed by alternating mudstone and sandstone layers that incline gradually downstream. The syncline is around  $8^\circ$ . On the right bank, there is a remarkable folded zone where a part of the layer shows a nearly vertical inclination. It was found during excavation near the river bed that there were a lot of clay-mediated, small angle weak layers inclined toward the downstream that might affect stability of the dam. The construction work, therefore, had to be suspended to assess physical properties, design changes to the dam foundation and additional excavation. Consequently, the excavation works took approximately three months longer than scheduled. It was decided to excavate 19 m deeper than originally planned and to increase the height of the dam from 148 m to 167 m. Additional excavation (mainly a shear key arranged at the lower part of the main dam) amounted to approximately  $45,000 \text{ m}^3$ .

Figure 2. Geological Cross-Section

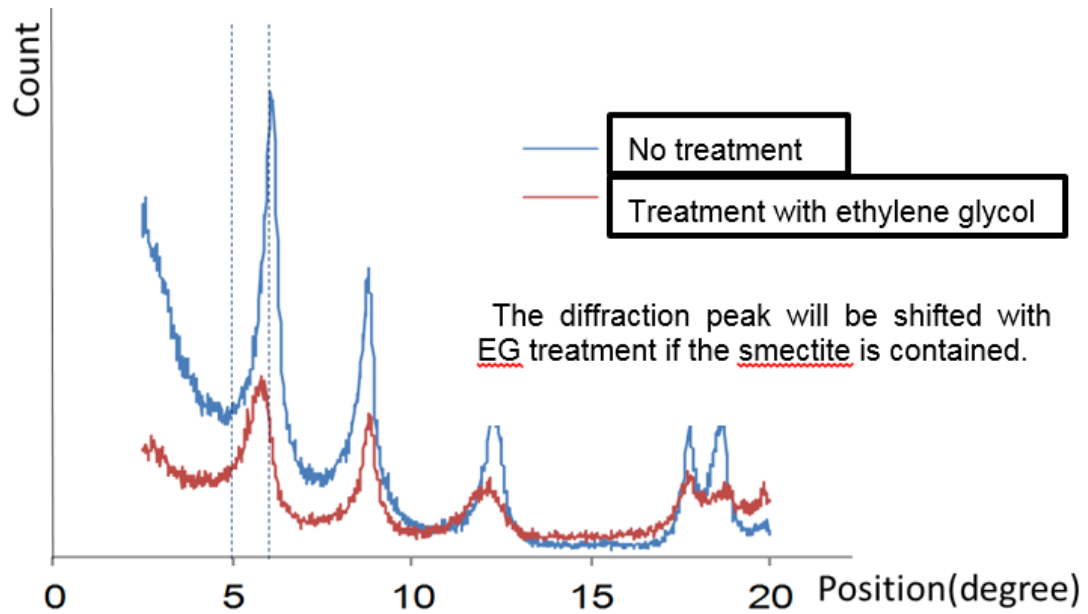
X-ray diffraction (XRD) analysis of samples was carried out in order to verify that these fine particle fractions in the weak layers did not include any swelling clay (for example, smectite) that might significantly degrade physical properties. It was quantitatively verified that swelling clay minerals such as smectite clay were not included (Figure 5). Detailed observation by means of CT scanning was carried out (Figure 6) in order to examine fractured parts. It is considered that the weak layers in relevant locations were formed by progressive weathering of the part that had been fractured by flexural-slipping in association with folding activity at the boundary of the hard sandstone and the soft mudstone due to pressure and the change in groundwater level. Since the fractured part existing under such FLD was not associated with fine particle fraction or the rearrangement of particles, it was verified that they were cracks, not continuous weak layers. For the hard rock parts, physical properties were determined from the results of the in-situ block shear test in the test pit and were verified using Hoek-Brown failure criterion (Table 1). Stability analysis of the dam was carried out using these physical properties.

Figure 5. Results of XRD Analysis

- The distribution of weak layers existing in alternating sandstone and mudstone was examined and physical properties were determined based on boundary tests of the samples taken from the site.
- A shear key was effective as a countermeasure against weak layers in the riverbed. It was also possible to perform economical designs by taking multiple measures, such as partially expanding the dam section and providing additional drainage holes upstream.
- The original design of the dam layout was appropriate but, taking into account the additional provision of a shear key, the final design was confirmed based on wedge analysis, finite element analysis and site investigation.
- Detailed observation by means of CT scanning and XRD analysis were effective for evaluating the continuity of weak layers and existence of swelling clay.

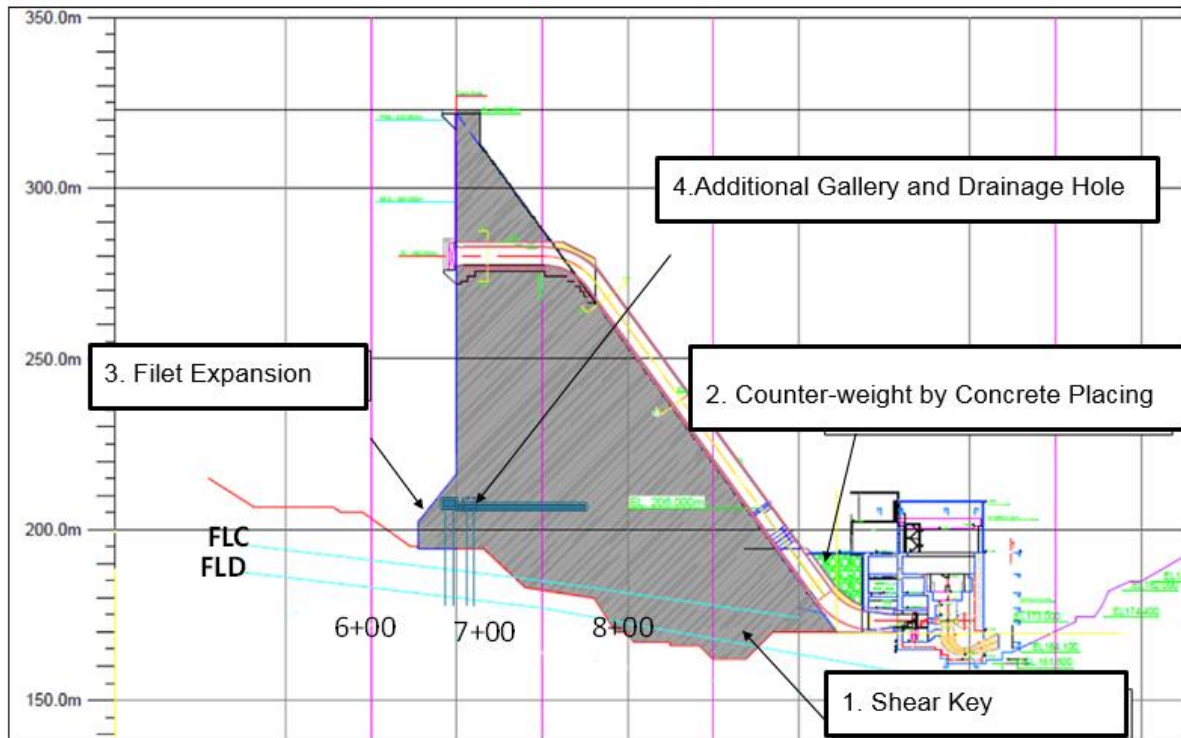
Wedge analysis was adopted to examine sliding force and resistance force of a small-angle weak layer by dividing it into multiple blocks along slip lines. Analytical conditions, necessary safety factors, etc. conformed to the United States Army Corps of Engineers (USACE) 1). The section (F+00) around the riverbed upstream of the powerhouse is shown as a model section. Since, in this section, the foundation rock around the toe of the dam was excavated in order to build a powerhouse downstream, the safety factor of sliding was the lowest. As external forces were considered the hydrostatic pressure upstream, hydrostatic pressure downstream, mud pressure, dynamic water pressure upstream, dynamic water pressure downstream, inertial force and uplift pressure. As for the uplift pressure, the decrease in uplift pressure by 66% due to a drain hole provided at a gallery downstream of the dam axis was assumed. Figure 7 shows a model of wedge analysis and Fig. 8 shows the external forces. Since the dam did not satisfy the necessary safety factor in planned excavation, additional excavation that would provide a shear key was required to remove weak layers and make use of shearing resistance force of robust rocks at deeper parts. While preparing the shear key required excavation into the bedrock, it was difficult to provide the shear key on the steep slope because it required a large amount of slope cutting, which takes time and cost. As shown in Fig. 7, therefore, multiple measures were adopted for dam stability such as a counter-weight by providing backfill concrete downstream, increasing the shearing length by expanding the fillet, adding weight by hydraulic pressure upstream and providing additional drainage holes in the gallery.

Figure 7. Outline of Wedge Analysis Model and Measures for Stability

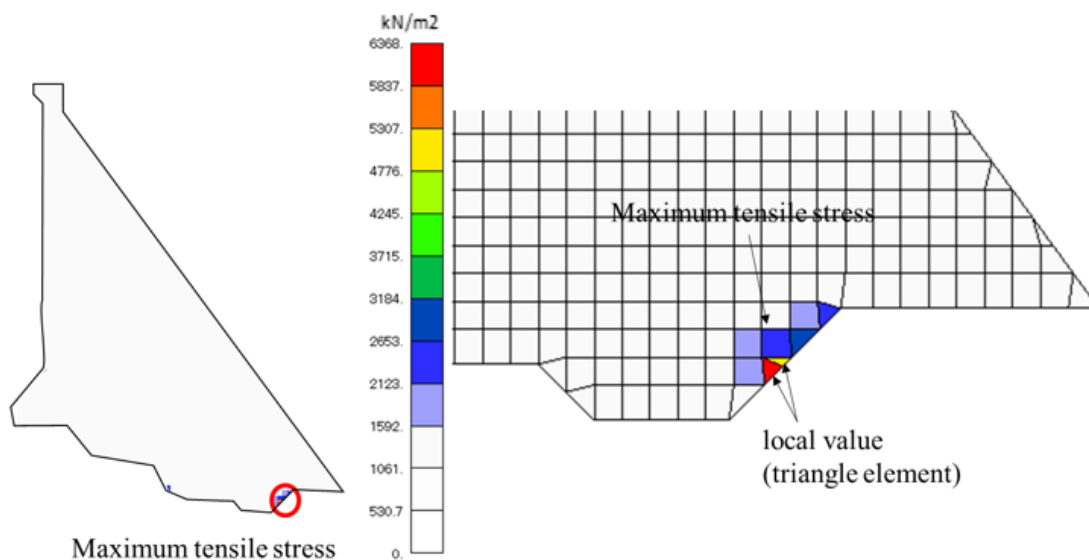
elements. The distribution of compressive stress, tensile stress, shearing stress, sliding safety factor, deformation, etc. were studied. Figures 9 through 12 show the distribution of compressive stress, distribution of tensile stress, and displacement of the weak layers in the case of an earthquake, which is critical for design, and a photo of re-bar installation. The largest points of compressive stress of the dam body and the foundation rock, which were acceptable considering the strength of the dam concrete and the foundation rock, were located around the toe of the dam. As for the tensile stress, it was found that the tensile stress was generated locally in the area around the boundary of the shear key and the weak layer, therefore it was decided to provide sufficient reinforcement in the part where large tensile stress was generated. Re-bar was installed to defend against crack propagation in the dam concrete, as a countermeasure to the large tensile stress. Since displacement of the weak layer was only 11 mm at a maximum, it can be evaluated that the displacement was well controlled by the shear key.

Figure 10. Distribution of Tensile Stress

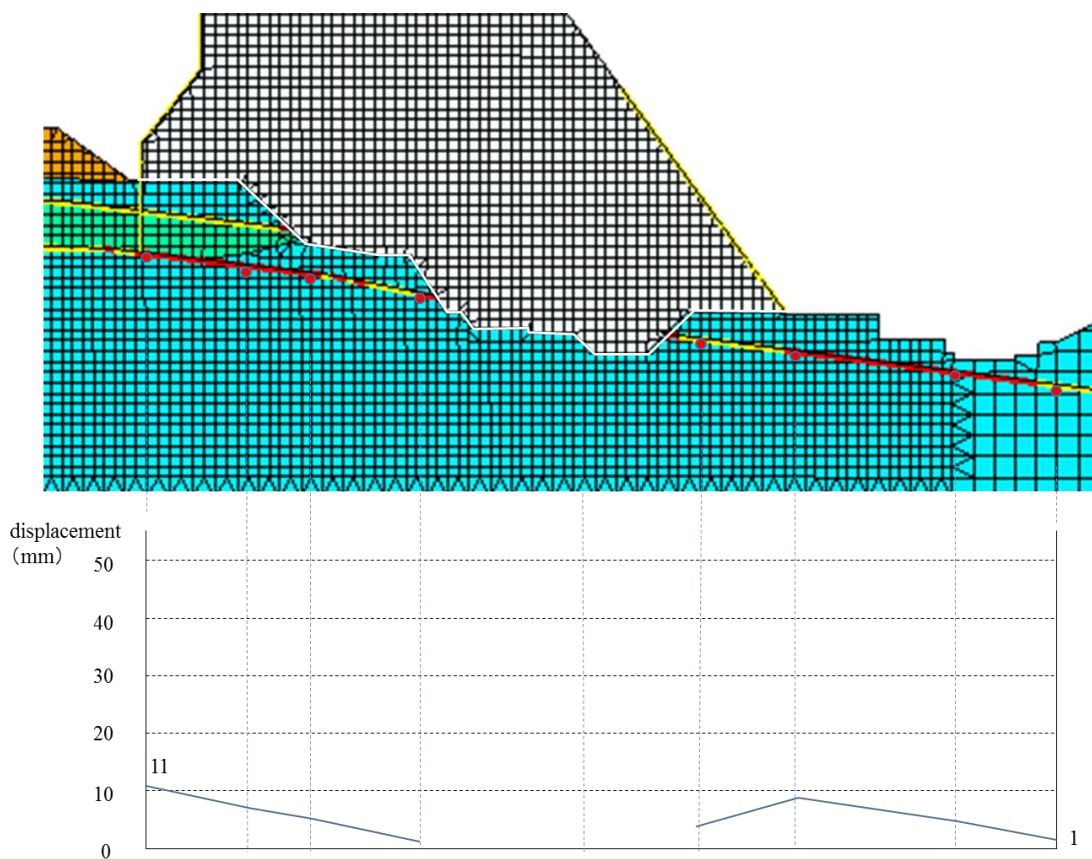
Figure 11. Displacement of Weak Layer

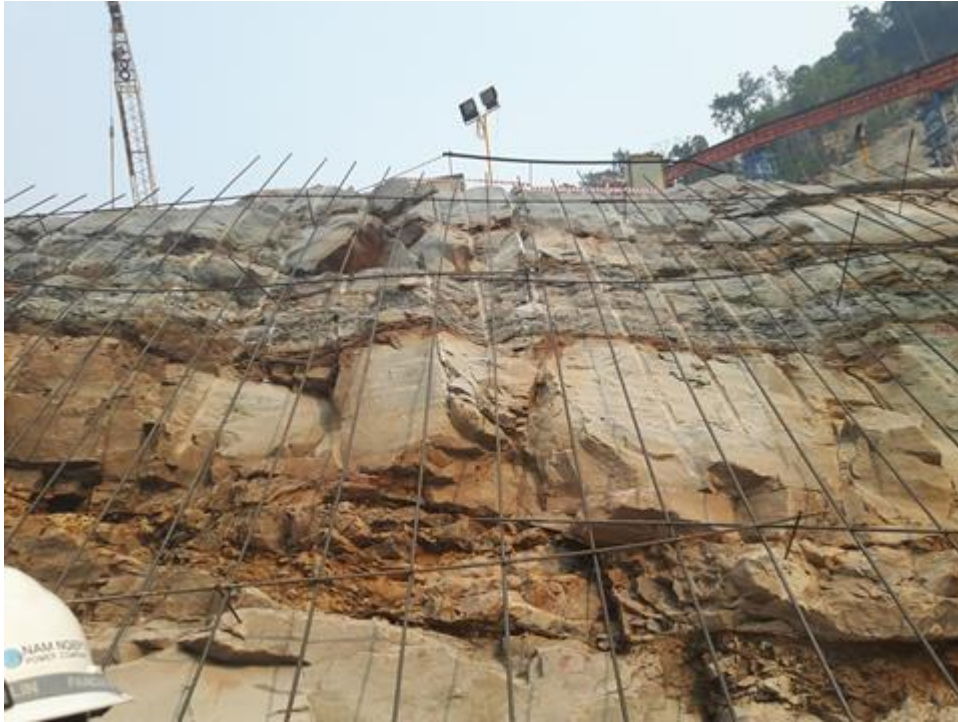
**Figure 12. Photo of Re-Bar Installation**

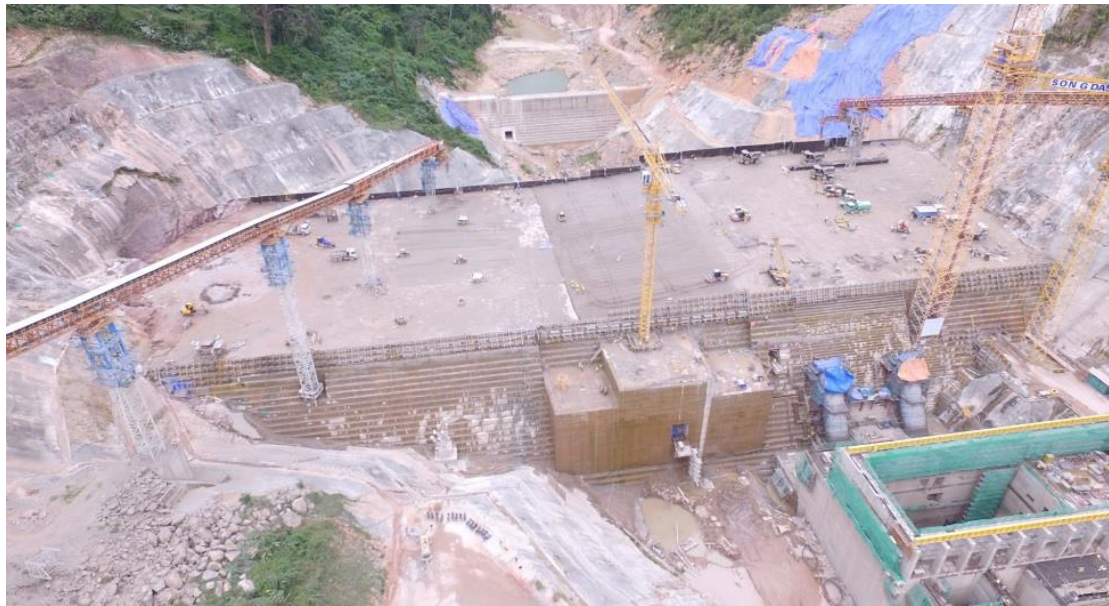
Finally, excavation of the foundation was completed in March 2016 and RCC placing was commenced in May 2016. As of the end of December 2016, approximately 690,000 m<sup>3</sup> (29%) of concrete had been placed for the main dam and the overall progress rate of the project was 59%. Figure 13 shows the state of concrete placing for the dam in December 2016. Utmost efforts are being made for a scheduled commencement of operation in January 2019.

**Figure 13 State of Concrete Placing at Dam (December 2016)**
