Measures against the predicted degradations of water quality of Makio dam by the volcanic eruption

Koudai Onoshima^{1,a}, Hiroomi Imamoto^{2,b}, Takeshi Miyashita^{3,c}, Yuujirou Ishiguro^{1,d}

¹*Aichi Canal System Control and Management Office, Japan Water Agency, Togo, Japan*

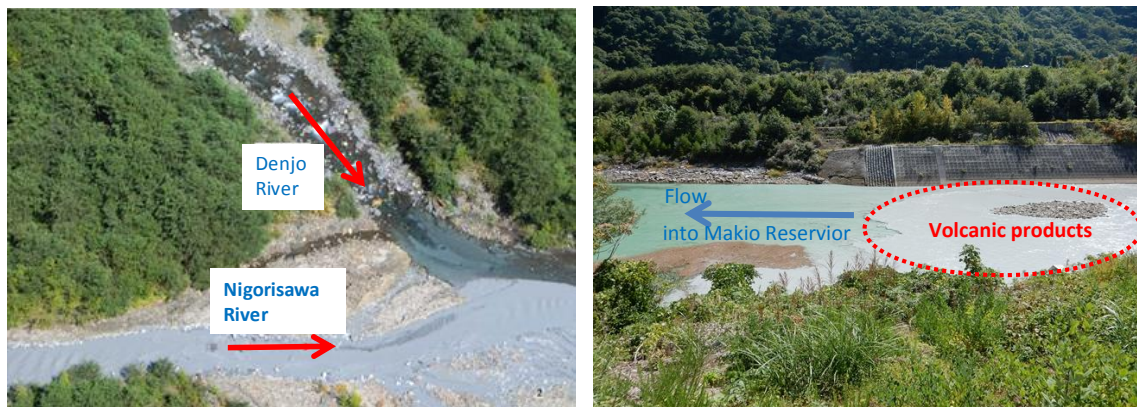
High turbidity water flowing into the reservoir through "Nigorisawa River".

Volcanic products accumulated at the flow-in point of the reservoir.

Figure 2. View of the inflow river and flow-in point of the reservoir on September 29, 2014

In the reservoir of Makio Dam, we have implemented water quality monitoring twelve times a year. Since many volcanic products entered into and accumulated in the dam after the eruption as shown in Figures 2, we determined to increase the number of monitoring points, frequencies, and items from the day following the eruption.

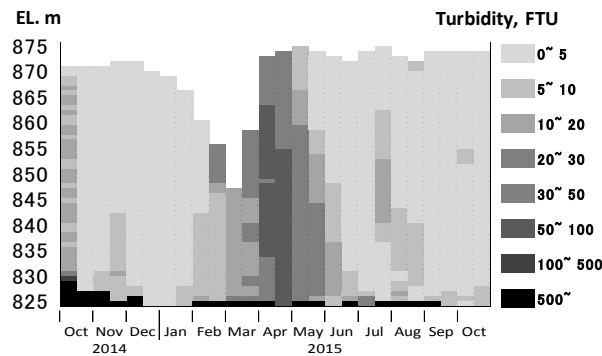
When the water with turbidity from several hundred FTU to not less than thousand FTU enters into the reservoir over a prolonged period, the turbid water usually diffuses and as a result, the reservoir remains highly polluted over a long period. When we examined the vertical distribution of the turbidity measured at the monitoring points in the dam site immediately after the eruption, as shown in Figure 5, a value of 500 or higher FTU was recorded (maximum of 380,000 FTU was recorded for the water sampled on October 16, 2014) only at the lower elevation from EL. 825 m to 829 m while smaller values were recorded at higher elevations. Since the high turbidity water flowing into the reservoir at the flood time contains particles of various sizes, coarse particles are deposited in the upstream and fine particles are deposited near the downstream dam site. Since the turbid water at the flow-in point

Figure 5. Change of vertical distribution of turbidity at 200 m dam site point

We observed that the turbidity in the reservoir maintained several tens FTU (Figure 5) while the high turbidity water entered into it as shown in Figure 4. For this reason, we implemented the present condition reproduction calculation to comprehend to what extent the turbid water reached the dam site as an underflow density current in the reservoir.

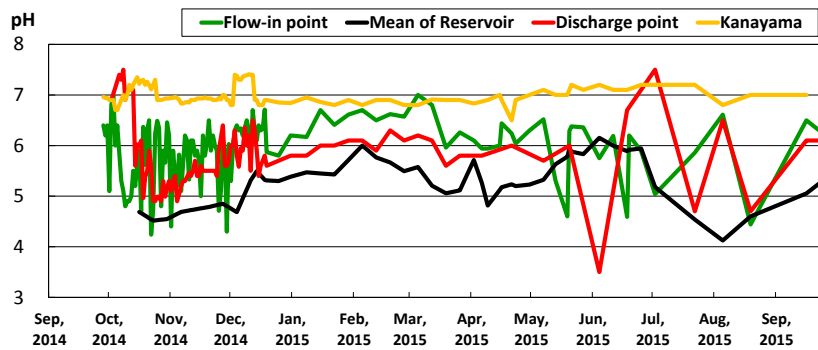
The pH at the flow-in point before the eruption stayed at a level of about 7.0, but decreased at least 4.0 during the period from October to December 2014 after the eruption as shown in Figure 7. After December 2014, the pH recovered to a level between 6.0 and 7.0 in the normal flow conditions but decreased to 4.5 at the flood time depending on the situation. It is estimated that much amount of volcanic products entered into the reservoir at the flood time and caused decreasing of pH value by their acidity. Same trend were applied for average pH of the reservoir (weighted average for all layers) and the pH of the discharged water.

Figure 7. Change of pH (September 2014 to September 2015)

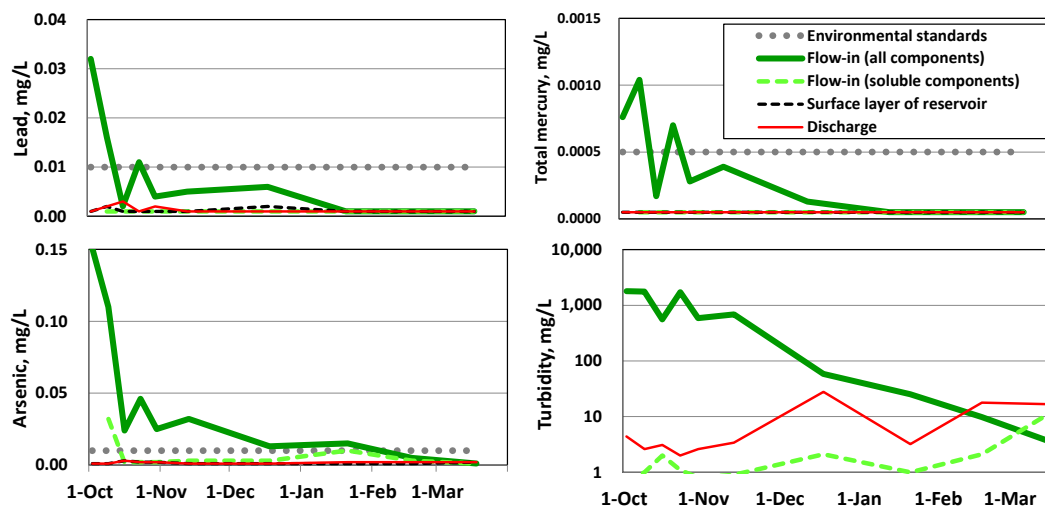
Substances whose concentrations exceeded the environmental standards as of October 2, 2014 immediately after the eruption were lead, arsenic, and total mercury as shown in Figure 8. The lead and total mercury exceeded the standards when the turbidity was higher than 1,000 FTU, while the arsenic exceeded the standards when the turbidity was higher than several ten FTU. All of them did not exceed the standards after the turbidity became lower than the normal level. Since these substances exceeding the environmental standards did not violate the standards with respect to soluble components (excluding the arsenic measured on October 9 (turbidity: 1,760 FTU)), it is estimated that most of these heavy metal adhered to the volcanic products. Cadmium, selenium, hexavalent chromium, fluorine, and boron did not exceed the standards.

Figure 8. Change of major substances affecting human health (October 2014 to March 2015)

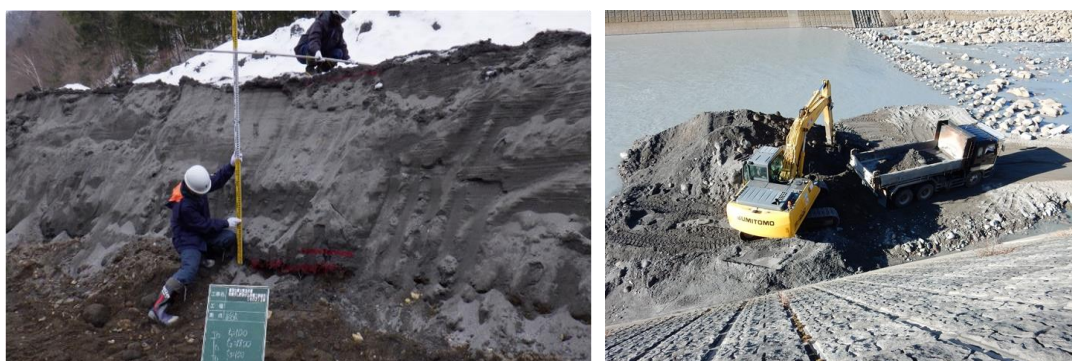
When we surveyed the condition of deposited volcanic products in October 2014, we found that about 670,000 m³ of volcanic products had been deposited in the sand collection dam located at the upstream end of the reservoir and on the bottom of the dam site. In particular, it was highly possible that the sediment at the upstream end of the reservoir would be scoured at the flood time and, therefore, we removed 15,000 m³ of volcanic products deposited in the sediment trap dam during the period between October 2014 and March 2015 and implemented appropriate disposal (Figure 10).

Figure 10. Removal of volcanic products deposited in the sediment trap dam (February 4, 2015)

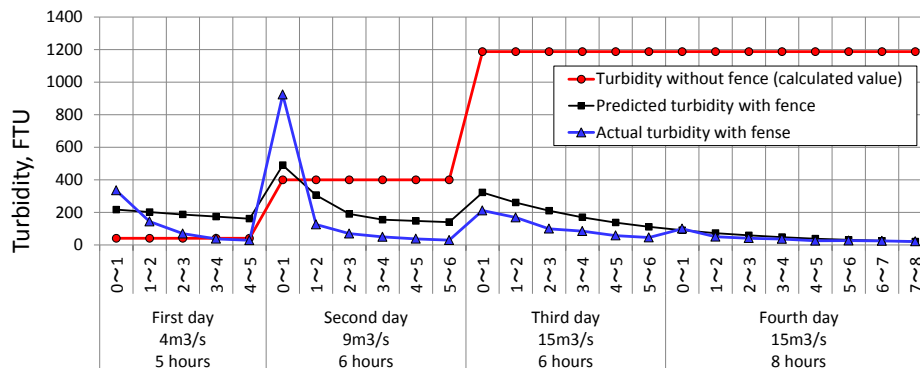
Figure 12. Turbidity at discharge point during test discharge (predicted and actual values)

As shown in Figure 12, the turbidity increased to the maximum of 900 FTU at the discharge point in the initial stage of the test discharge but showed a rapid reduction tendency over time and became almost the same level as the forecast.

Before the test discharge, we forecasted the discharged turbidity based on a water quality prediction model. In this forecast, taking into consideration the flowing layer thickness as well as the vertical distribution of the turbidity in the reservoir, we calculated the discharged turbidity under the assumption of the existence of two different layers (i.e., high turbidity water layer and low turbidity water layer was an initial condition as shown in Figure 11.). This study proved that the discharged turbidity of 1,200 FTU lasted for a long period in the case where the water pollution prevention fence was not used but the discharged turbidity decreased within one to two hours when the fence was used, as shown in Figure 12. Therefore, we implemented the test discharge after getting approval from the Study Committee.

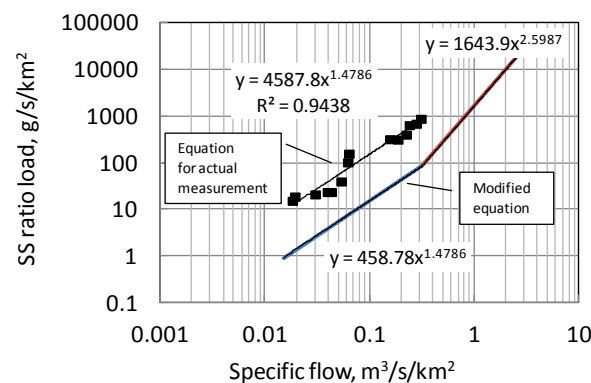
Then, we created the relationship equation of Suspended Substance (SS) ratio load (L) and specific flow (Q) (Figure 13). This equation (L-Q equation) was based on the actual measurement of water quality survey result. When we implemented the present condition reproduction calculation with L-Q equation, the vertical distribution of the turbidity in the reservoir indicated several thousand FTU and substantially differed from the measurements shown in Figure 5. Therefore, we modified the L-Q equation and corrected the turbidity to 1/10 of measurements, the turbidity condition in the reservoir at the flood time and the increase of and later reduction of turbidity in the low-level condition could be reproduced accurately (Figure 14). Therefore, it is estimated that 90% of the high turbidity water entering into the reservoir reached the dam site in the form of underflow density current and 10% of the water dispersed in the reservoir.

Figure 13. Actual measurement L-Q equation and modified L-Q equation

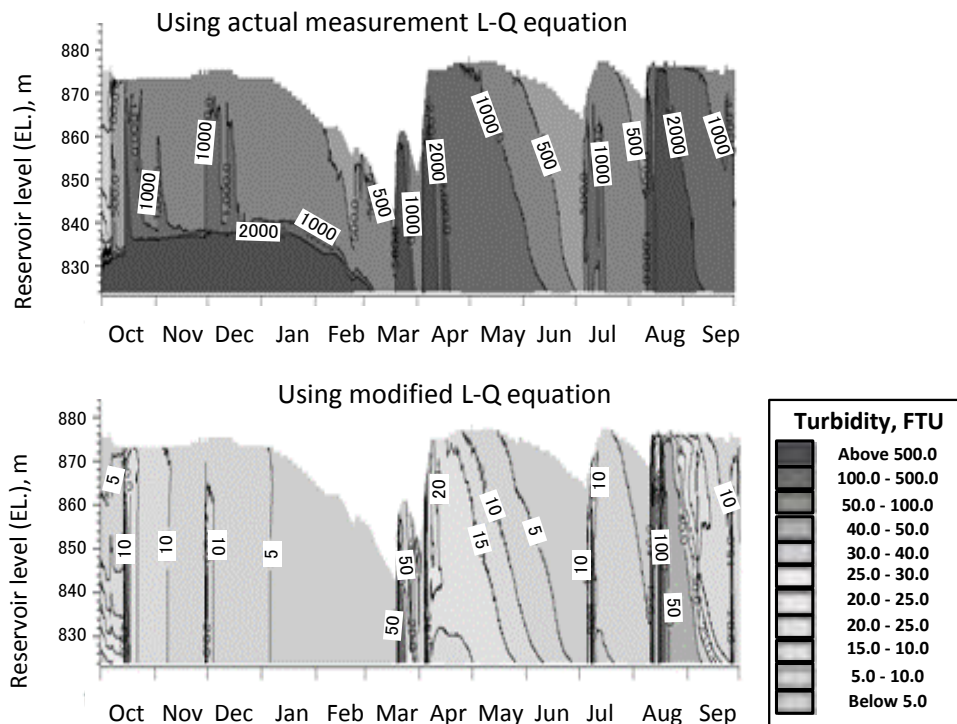
Figure 14. Result of forecast of vertical distribution of turbidity (October 2014 to September 2015)
