PRELIMINARY INVESTIGATION OF DAMS STRICKEN BY THE IWATE-MIYAGI NAIRIKU EARTHQUAKE IN 2008

Yoshikazu YAMAGUCHI and Tomoya IWASHITA

Public Works Research Institute, Japan, e-mail: yamaguti@pwri.go.jp, iwashita@pwri.go.jp

ABSTRACT:

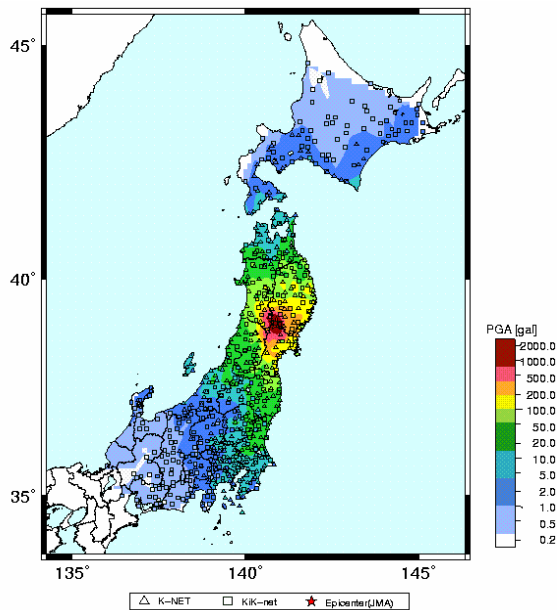
Figure 1 Peak ground acceleration contour map based on KiK-net and K-NET operated by NIED (NIED, 2008)

National Research Institute for Earth Science and Disaster Prevention (NIED) operates the strong motion instrumentation networks, K-NET and KiK-net. Strong motions were recorded at 330 and 325 stations respectively. Based on their data, a peak ground acceleration contour map was drawn as shown in Figure 1. The KIK-net station, IWTH25 almost on the earthquake fault recorded over 1g of peak acceleration at the location of underground level -260m where S-wave velocity is 1.8km.

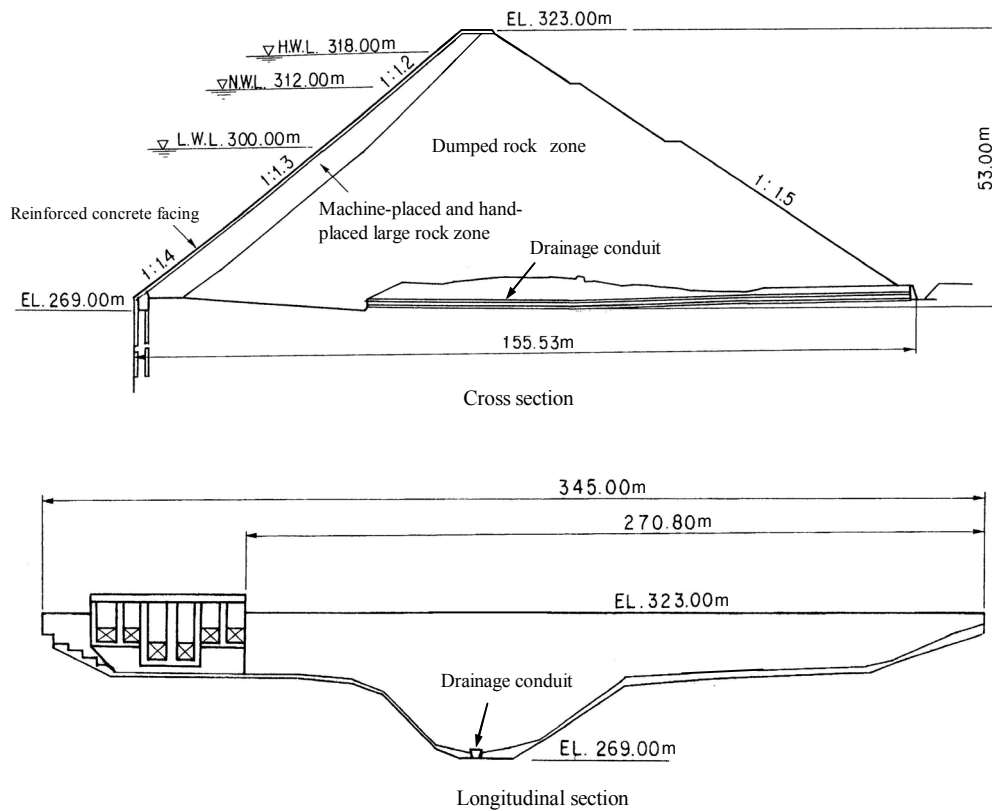
Figure 3 Cross section and longitudinal section of Ishibuchi Dam

Ishibuchi Dam is a concrete faced rockfill dam (CFRD) with a dam height of 53m completed in 1953, and managed by Tohoku Regional Bureau, MLIT. Figure 3 is the cross section and longitudinal section of the dam. The upstream concrete face maintains the watertightness of dam body of this type of dam. No severe damage was found in the concrete face and its joints shown in Photo. 1.
