# Abrasion and Corrective Measures of a Sediment Bypass System at Asahi Dam

**T. Nishikawa & Y. Yamane**

This paper describes the abrasion of the tunnel invert of the sediment bypass system at the Asahi Dam that has been in operation for approximately 15 years, and evaluates possible tunnel maintenance methods using the life-cycle cost based on monitored data of abrasion.

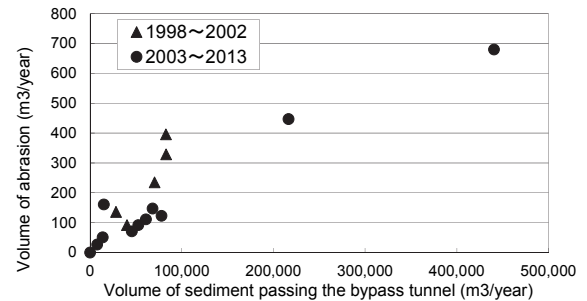
**Figure 10.** Relationship between the volumes of abrasion and sediment passing the bypass tunnel

The results of measurement of the volume of sediment that passed the bypass tunnel, volume of abrasion in the tunnel invert and the volume of materials used for repair are shown in Fig. 9 in order to quantitatively evaluate abrasion. The changes in abrasion volume affected by the volume of sediment passing the bypass tunnel were indicated by the relation between annual volume of abrasion and sediment load in the bypass tunnel (annual abrasion volume (m<sup>3</sup>/year)/sediment load in the bypass tunnel (m<sup>3</sup>/year) (Fig. 10). The volume of abrasion tends to increase nearly in proportion to the volume of sediment that passed the bypass tunnel. The volume of abrasion that was highest in 2011 when the maximum flow was recorded. The percentage of high-strength concrete increased on the invert surface of the bypass tunnel owing to periodical repair (Fig. 11). Fig. 10 shows that the volume of abrasion relative to the volume of sediment decreased from 2003 when the percentage of high-strength concrete exceeded
