VINGT TROISIÈME CONGRÈS
DES GRANDS BARRAGES
Brasilia, Mai 2009

**REHABILITATION OF THE TAISHAKUGAWA DAM WITH THE AIM OF
IMPROVING FLOOD DISCHARGE CAPACITY AND SEISMIC STABILITY ***

The Chugoku Electric Power Co., Inc., one of the major electric utilities in Japan, executed the rehabilitation of an old concrete gravity dam with the aim of improving flood discharge capacity and seismic stability.

The rehabilitation work of the Taishakugawa dam commenced in June 2003 and was completed in June 2006.

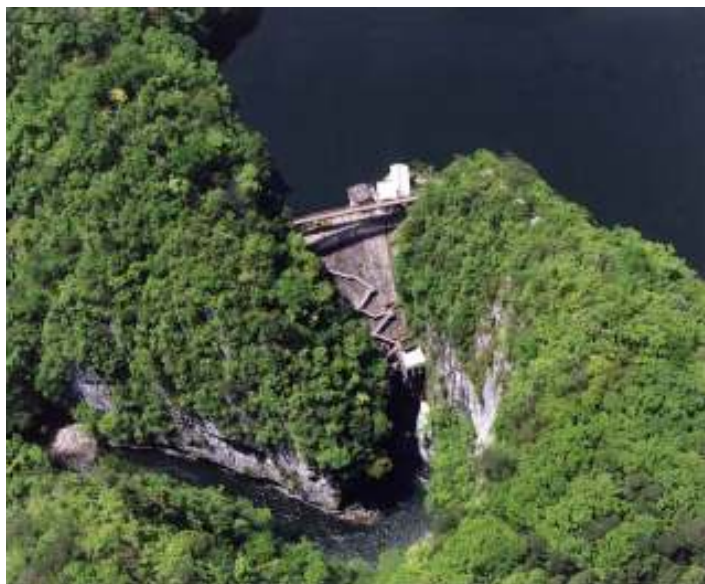
Fig. 4

The Taishakukyo Valley where the Taishakugawa dam is located is a deep valley that was formed with the erosion by the Taishakugawa River flowing at the center of the Taishakudai Plateau. As for the surrounding area of the dam, the extremely steep cliffs made of limestone are consecutive, as shown in Fig. 4.

Steep cliffs of limestone around the dam site
Falaises de calcaire autour du site du barrage

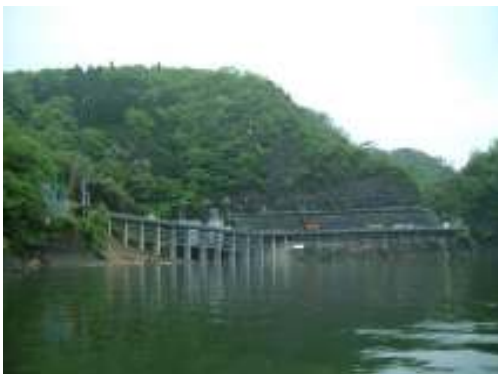
According to the circumstances above mentioned, Steel-made temporary road of about 170m was set in the reservoir because there was no road by which the vehicles for construction was able to access to the dam site. Moreover, the dam concrete was placed by setting up similar steel-made temporary stage (43m in maximum height) on the downstream of the dam, and by using 80t crawler crane. Fig. 9 and 10 show the steel-made temporary road in the reservoir and the steel-made temporary stage on the downstream of the dam respectively.

Fig. 9
Steel-made temporary road
in the reservoir
*Route temporaire en acier
dans le réservoir*

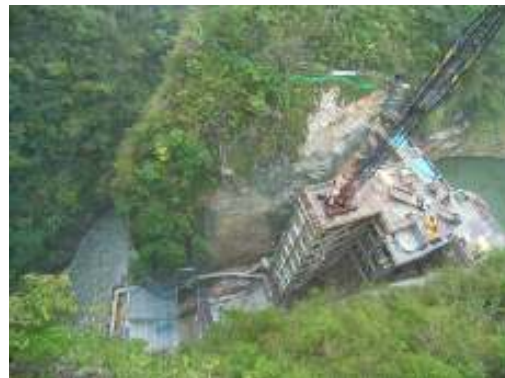
Fig.10
Steel-made temporary stage
on the downstream of the dam
*Palier temporaire en acier
en aval du barrage*
