VINGT SIXIÈME CONGRÈS
DES GRANDS BARRAGES
Vienne, Juillet 2018

**SLAKING COUNTERMEASURES RELATED TO ROCK CONTACT
EXECUTION AT THE SOFT ROCKS FOUNDATION***

Satoshi YOSHIMURA, Singo TAKASUGI
Apporo Dam Construction Office, HOKKAIDO PREFECTURAL GOVERNMENT

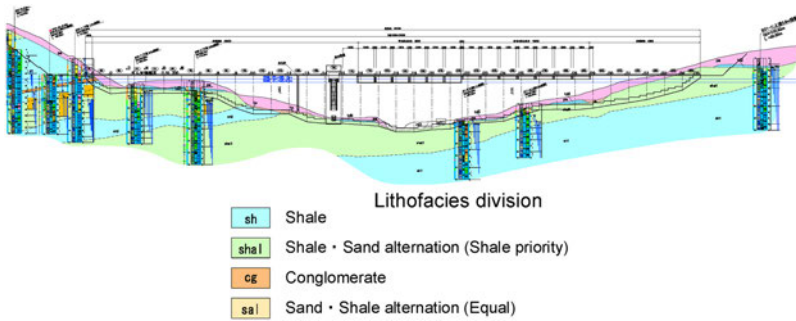
Fig. 2
Geological longitudinal section of dam site
Coupe longitudinale géologique du site du barrage

At the dam site, Karumai formations consisting of Neogene-Miocene sedimentary rock are distributed. The dam foundation is mainly shale strata (*sh strata*) and alternation strata of shale and sandstone (*shal strata*), enclosing thinner stratum of conglomerate (*cg strata*) or tuff (*tf strata*) (see Figs. 2 and 3). These layers of foundation bedrock are covered with fallen volcanic ash and pumice stone in the

Quaternary distributed to a depth of about 10 m. The strata of the foundation bedrock are inclined at an angle of about 20° on the upstream side of left abutment, but no large-scale fault fracture zones are distributed. The shale strata (*sh strata*) and the alternation strata of shale and sandstone (*shal strata*) of the dam foundation form massive bedrock with few cracks and with unconfined compressive strength from about 20 to 50 N/mm² in the fresh parts. Additionally, its concreteness of bedrock permits to occur cracks of its own when struck hard by a hammer, but in the shallow bedrock, cracks to form along the bedding plane has been confirmed [1].

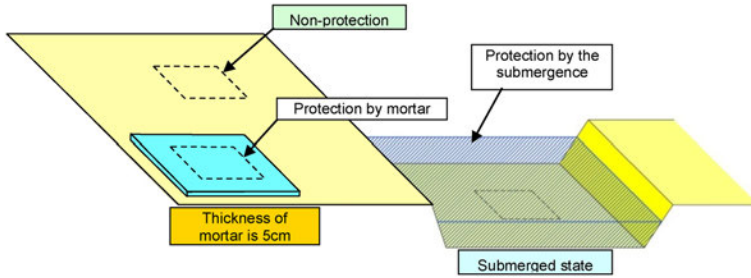
Fig. 5

Heavy machinery was used to remove only the loosened and weathered parts (about 30 to 50cm in depth) at the trench bottom which was excavated and exposed for several years. On the fresh *shal strata* of the riverbed trench, another deeper trench was excavated to prepare three test surfaces (each, 1.5m×1.5m): non-protection, protection by submergence, and protection by mortar (see Fig. 5).

Schematic view of in-situ slaking test at preliminary survey
Vue schématique du test de relâchement in situ à l'enquête préliminaire

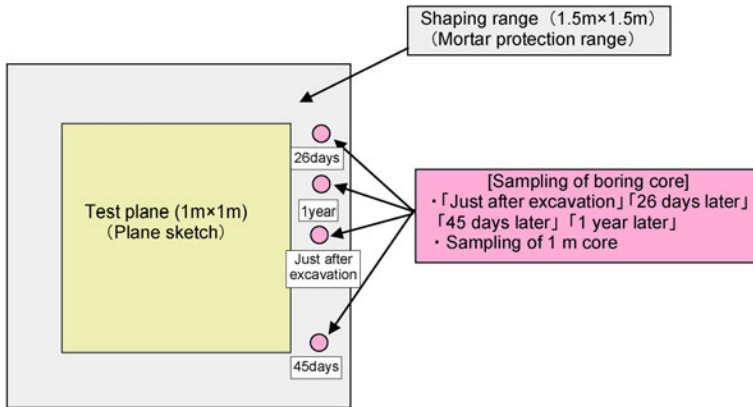
Fig. 7
Schematic plan of test surface
Plan schématique de la surface de test

Each test surface was confirmed the state of cracks 3 hours, 6 hours, 1 day, 2 days, 3 days, 7 days, 26 days, 45 days and 1 year after the excavation (see Fig. 6), then the slaking depth was measured by cores sampled 26 days, 45 days and 1 year after the excavation. Locations of cores are shown in Fig. 7.

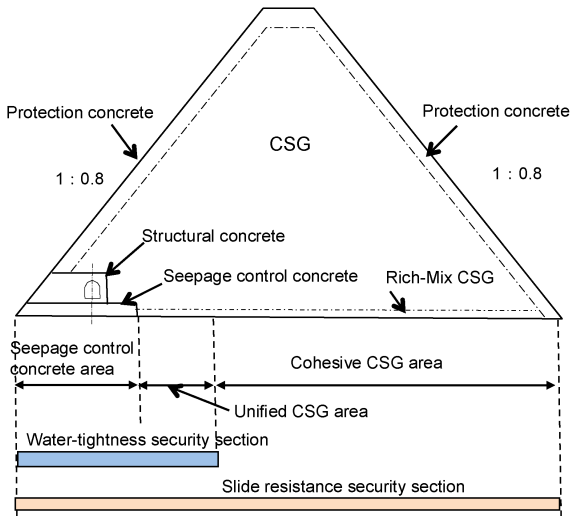
Fig. 8

As described above, it has been confirmed by slaking tests during the preliminary survey that the foundation bedrock of Apporo dam shows slaking properties. On the other hand, the base of a trapezoidal CSG dam in contact with the foundation ground is divided into seepage control concrete area, unified CSG area, and cohesive CSG area [2] (see Fig. 8).

Rock contact division at the base of CSG dam

The foundation treatment method that includes rough excavation, secondary excavation, bedrock cleaning, and placing is categorized for seepage control concrete area and unified CSG area those require foundation treatment similar to that of a concrete gravity dam, and for cohesive CSG area where exfoliated or loosened rock, etc. caused by rough excavation are removed. Therefore, for each foundation of seepage control concrete area, unified CSG area and cohesive CSG area, it was necessary to establish the foundation treatment method considering slaking from rough excavation, secondary excavation, bedrock cleaning, and placing [3]. In the following chapter, practical treatment method during execution will be described.

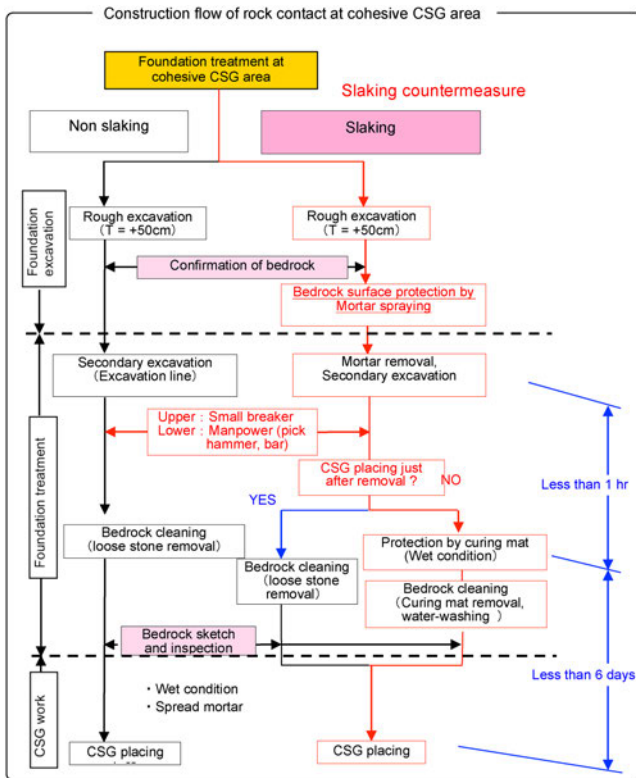
Fig. 9
Construction flow of rock contact at the dam foundation (cohesive CSG area)
Flux de construction du contact rocheux à la fondation du barrage (zone cohésive CSG)

Regarding the suitability of foundation treatment method at Apporo dam, as shown in Fig. 9, the duration and construction cycles required to spray mortar to

protect the exposed surface after the rough excavation were investigated by confirmation test. As the next step, the duration and construction cycles required to maintain moisture condition using a curing mat after removal of the sprayed mortar (and secondary excavation), were also studied by the same test. Fig. 9 shows the foundation treatment for cohesive CSG area. Just before the construction of CSG part in rock contact, the confirmation test to verify the process of foundation treatment for slaking (including test to confirm looseness of foundation bedrock) was performed.

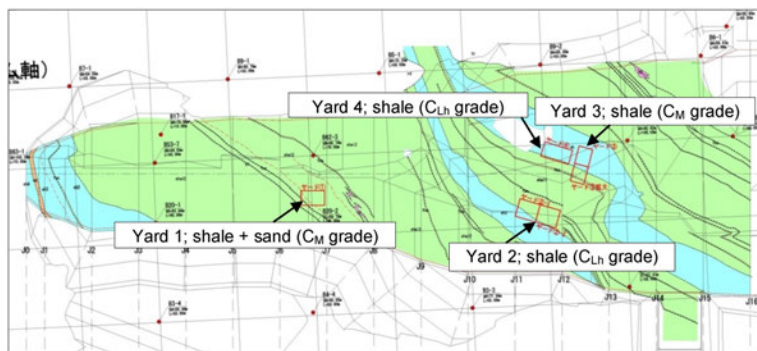
Fig. 10
Locations of slaking confirmation test (left side of the dam base)
Emplacements du test de validation de relâchement (côté gauche de la base du barrage)

Fig. 10 shows the locations of the four test yards selected.

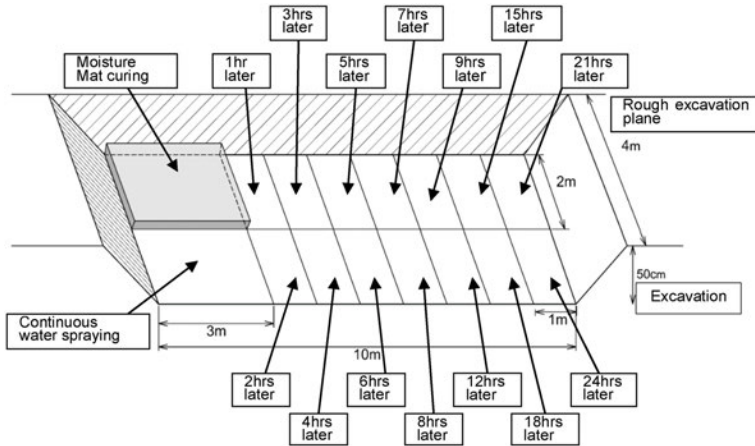
Fig. 11

- (3) The test was, as shown in Fig. 11, done for three cases: “continuous water spraying”, “moisture mat curing”, and “non-protection” where any curing of exposed surfaces was not performed. The exposed surface with non-protection was observed at every one hour to confirm the advance of slaking.
- (4) Sketches of the surface observed during each test were made. When slaking was seen, the depth of crack was measured, and at the same time as the repulsion degree was also measured with a Schmidt hammer.

The shape of the trench and division on test surface
La forme de la tranchée et la division de la surface de test
