## INVESTIGATION OF DAM PERFORMANCE DURING THE NOTO HANTO EARTHQUAKE IN 2007, JAPAN

Tomoya IWASHITA<sup>1</sup>, Nario YASUDA<sup>2</sup>,  
Kazuhito SHIMAMOTO<sup>3</sup> and Tomoki OTANI<sup>4</sup>

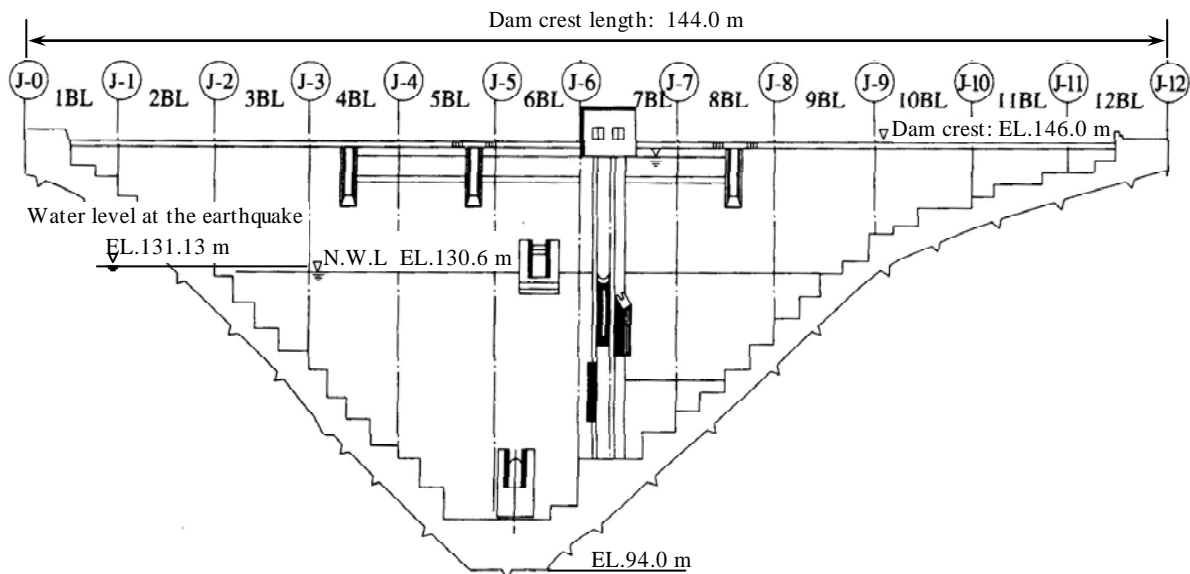
Fig. 6 Upstream face of Hakkagawa Dam

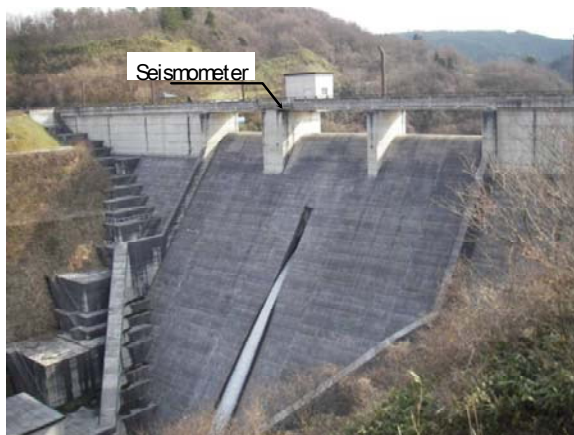
Figure 6 shows the upstream face of Hakkagawa Dam. Photograph 1 shows the downstream face of the dam body and the location of the crest seismometer. The peak accelerations at the crest (installed in the pier top of the crest bridge shown in Photo. 1) were 848.6 gal in the stream direction, 705.4 gal in the dam axis direction, and 266.9 gal in the vertical direction and those at the dam foundation were mentioned above.

Photo. 1 Downstream face of Hakkagawa Dam

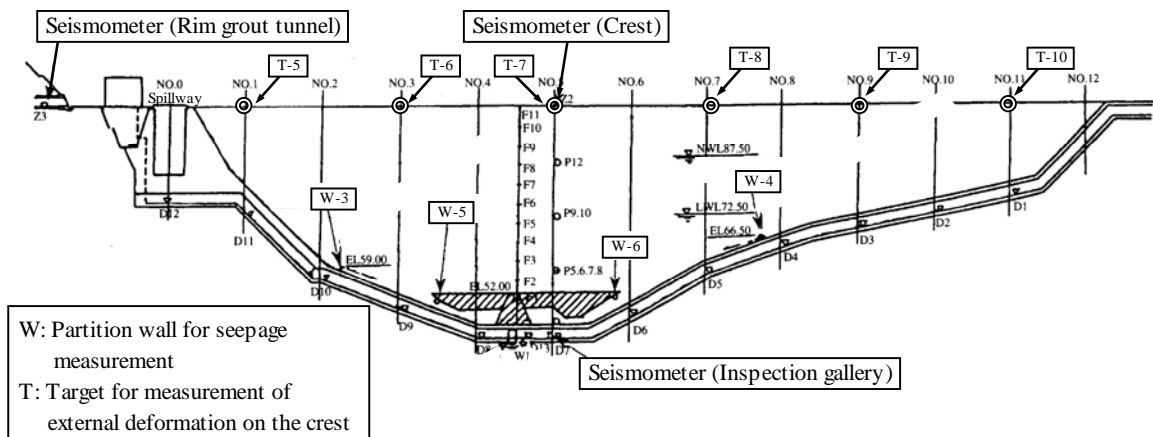
Seepage through the impervious earth core is measured at four separate zones (W-3 to W-6) as shown in Fig. 9. The change in seepage at the time of the 1993 earthquake was almost at the same level of the scattering of seepage amount before/after the earthquake, as shown in Fig. 10.

Fig. 9 Longitudinal section of Oya Dam

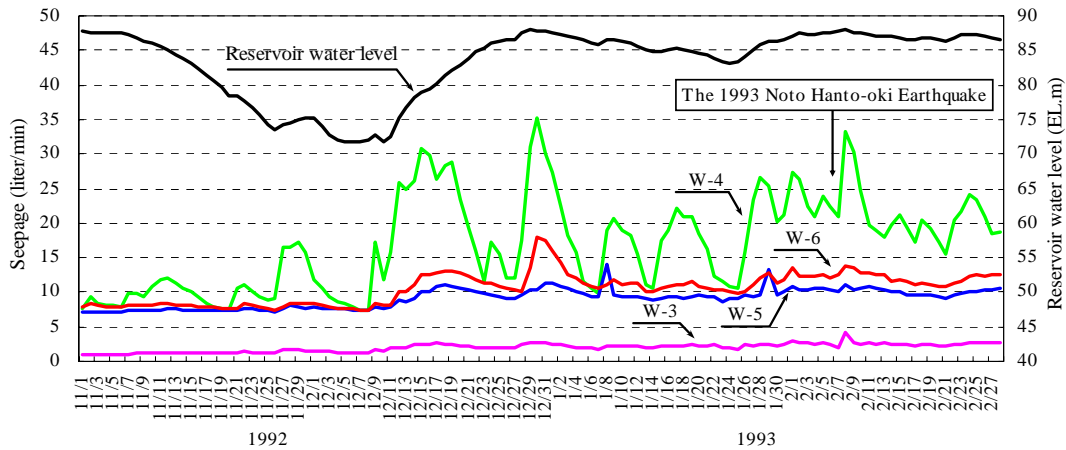
Fig. 10 Change in seepage amount through the earth core before and after the 1993 Noto Hanto-oki Earthquake

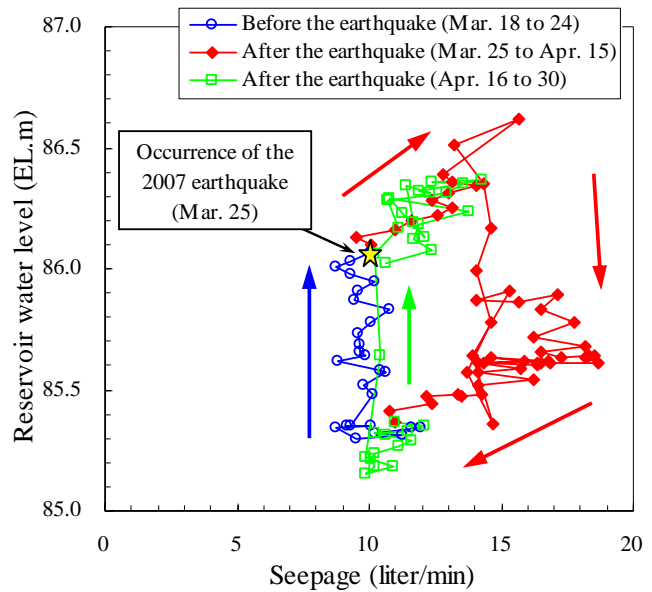
zones there was almost no change. Figure 12 shows the relationship between the seepage amount at Zone W-5 and the reservoir water level before the earthquake (March 18–24, 2007) and after the earthquake (March 25 to April 30, 2007). This figure indicates that the seepage amount during the period of about twenty days after the earthquake (diamond symbols) is larger than the seepage measured before the earthquake. Rainfall of 15 mm occurred on the day before the earthquake. On the other hand, the seepage amount measured about twenty days after the earthquake (square symbols) agrees well with that measured before the earthquake. The slight increase in seepage at Zone W-5 may not have been caused directly by the excitation of the earthquake, but may instead have been caused by the rainfall and change in reservoir level rise before/after the earthquake.

Fig. 12 Relationship between seepage and reservoir water level before and after the 2007 Noto Hanto Earthquake
