LA 78^{EME} CONGRES
DES GRANDS BARRAGES
Hanoi-Vietnam, may 2010

**EXTERIOR DEFORMATION MEASUREMENT
FOR CFRD AFTER A LARGE-SCALE EARTHQUAKE USING GPS**

This paper reports on the results of the installation of an external displacement measurement system using GPS at the Ishibuchi Dam which was damaged by the Iwate-Miyagi Nairiku Earthquake of June 14, 2008 immediately after the earthquake, and the subsequent use of the system to perform safety management based on real-time displacement measurement.

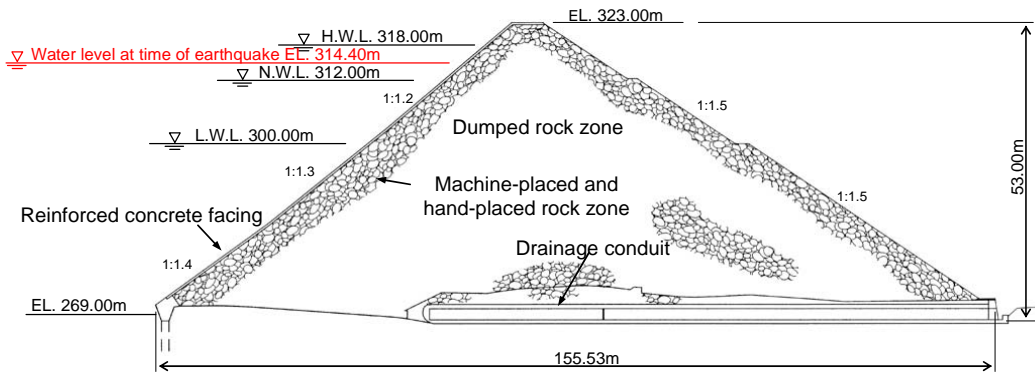
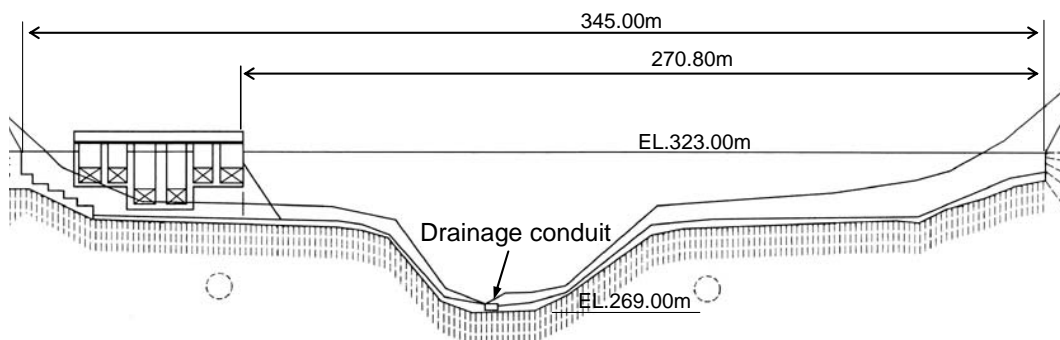
Ishibuchi Dam is a concrete faced rockfill dam (CFRD) with a dam height of 53m completed in 1953, and managed by Tohoku Regional Bureau, MLIT. Fig. 1 is the cross section and longitudinal section of the dam. The upstream concrete face maintains the water tightness of dam body of this type of dam. No severe damage was found in the concrete face and its joints shown in Fig. 2.

Cross section and longitudinal section of the Ishibuchi Dam

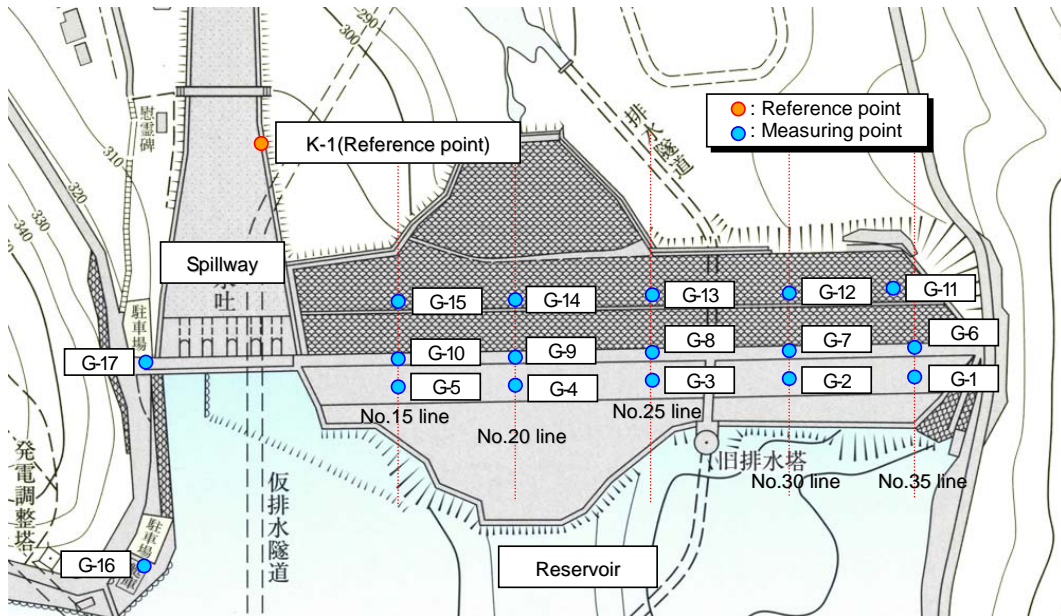
Fig. 9

The GPS sensors were, as shown in the plane diagram in Fig. 9, installed at a total of 18 points: 5 points on the reinforced concrete facing on the upstream side of the dam body (G-1 to G-5), 5 points near the dam crest (G-6 to G10), 5 points on the downstream side of the dam (G-11 to G-15), on the top of the boat

house on the left bank of the dam body (G-16), on top of the spillway pier (G-17), and at a reference point (K-1). The measurements started on June 26, 2008, which was 12 days after the earthquake.

Layout of GPS sensor installation points

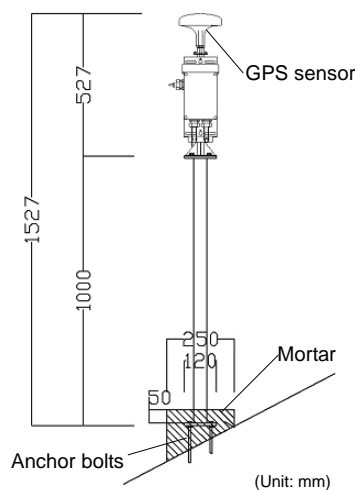
Fig. 10 is a detailed structure of GPS sensors installed on the upstream and downstream slopes of the dam. The sensors were fixed with anchor bolts on top of the reinforced concrete facing and the rock material and their bases were protected by mortar. Figs. 11 and 12 show installed sensors.

Structure of GPS sensor installed on the upstream and downstream slope of the

dam

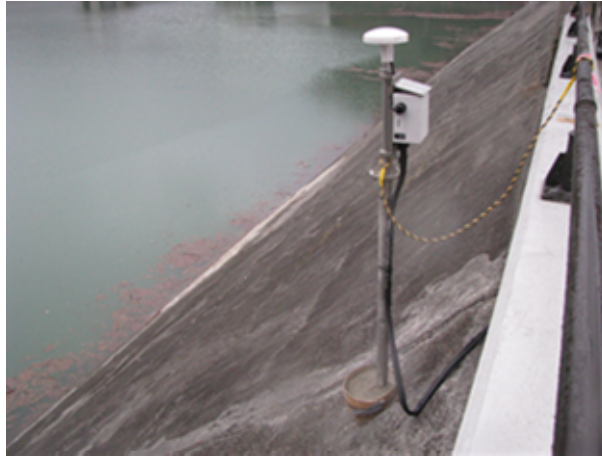
Fig. 11

GPS sensor installed on the reinforced concrete facing on the upstream slope of the dam

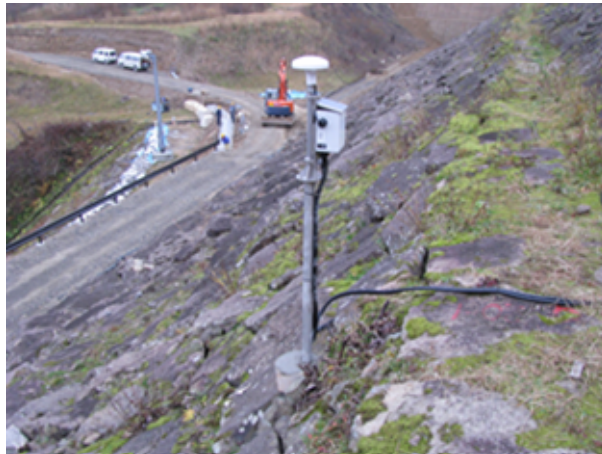
Fig. 12

GPS sensor installed on the rock block on the downstream slope of the dam

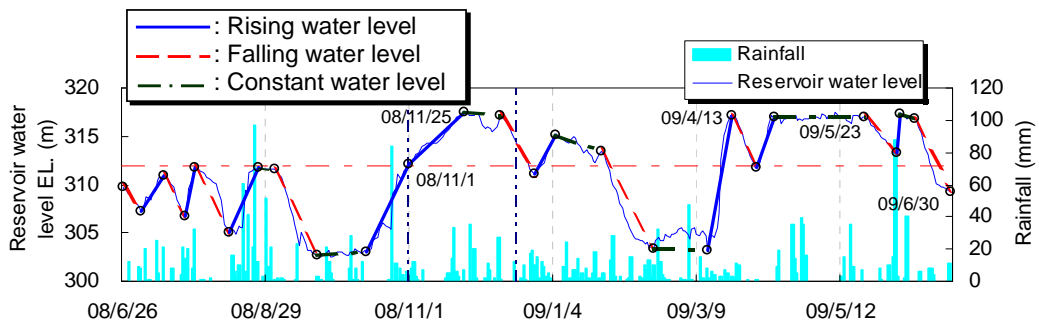
Fig. 14

shown in Fig. 14, classifying the reservoir water level conditions during the measurement period as reservoir water level rising time (solid lines), reservoir water level falling time (dotted lines) and constant reservoir water level time (dashed-dotted lines). And Fig. 15 shows resultant vectors of upstream-downstream and vertical displacement at the G-4 point on the upstream concrete face, the G-9 point near the dam crest, and the G-14 point on the rock block on the downstream slope of the dam. On the Fig.15, the horizontal axis is the upstream–downstream displacement and the vertical axis is the vertical displacement.

Displacement categorization conditions according to reservoir water level
