COMMISSION INTERNATIONALE DES GRANDS BARRAGES ----- LA 78 ^{EME} CONGRES DES GRANDS BARRAGES <i>Hanoi-Vietnam, may 2010</i>	
--	--

A STUDY FOR THE BEHAVIOR OF GROUNDWATER FLOW ALONG THE OPEN FISSURES WITH HIGH DIP ANGLES

The Yashio dam which is the upper dam of the Shiobara Power Plant has a thin ridge at the right bank of its reservoir.

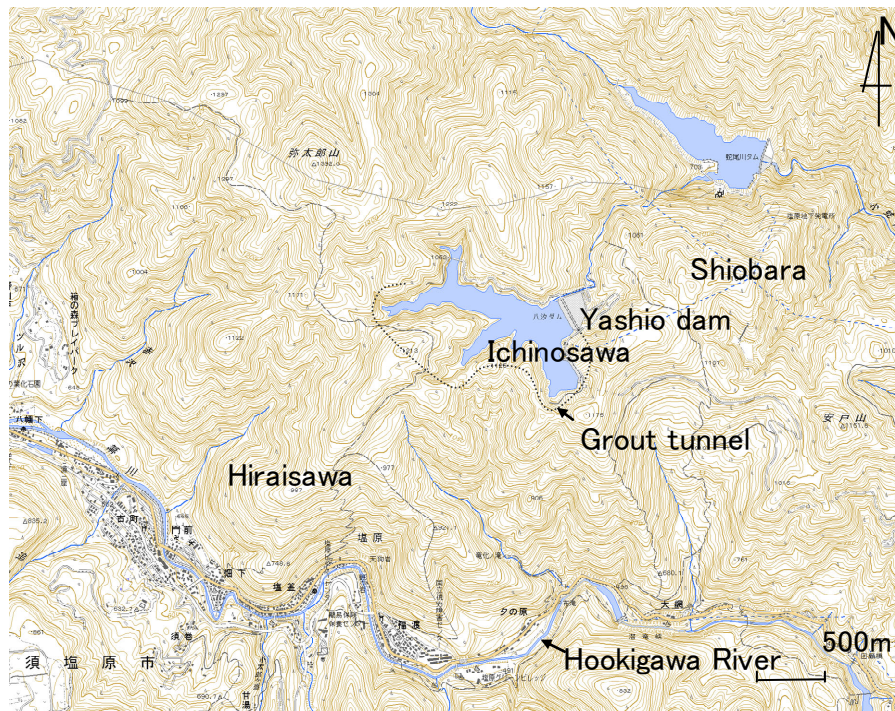
Fig. 1
Plan of the Shiobara Power Plant

The smallest thickness of the thin ridge is about 100 m at the elevation of HWL (EL.1,048m) of the reservoir. We have been worried about potential leakage through the thin ridge to the opposite mountain stream because of its thickness and the intrusive nature of the rock (porphyrite) with dense columnar joints (Fig. 1, Fig. 2).

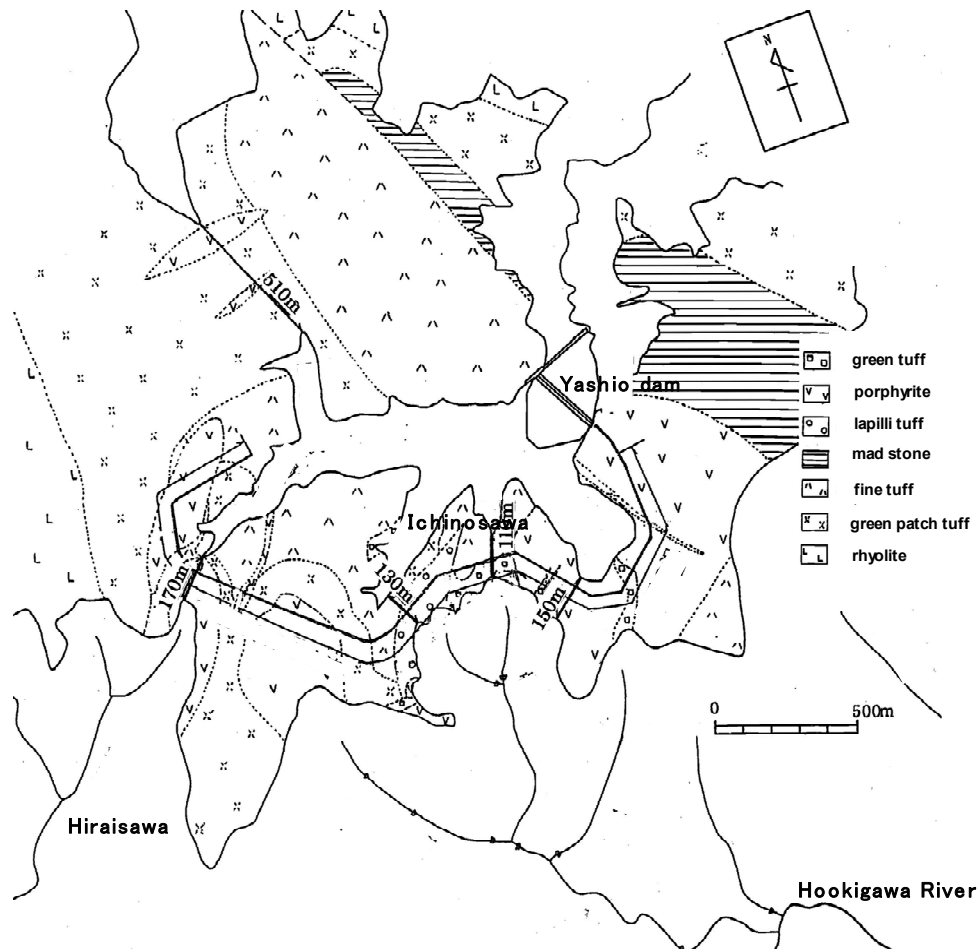
Fig. 2

Plan of the slice of the around of the Yashio dam reservoir at EL.1,048m(HWL)

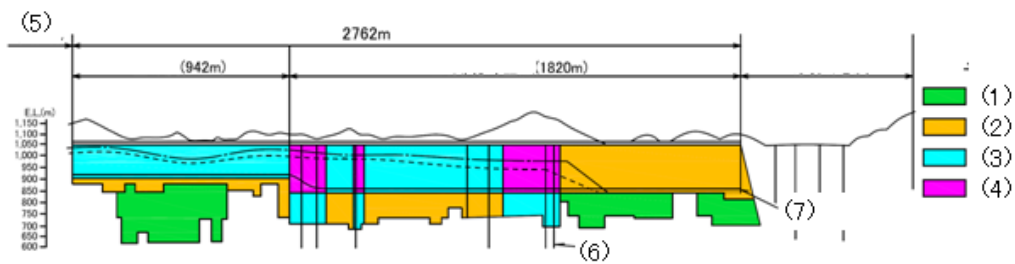
Fig.3

With this context, we had conducted the curtain grouting from the tunnel which we installed at the ridge of the right bank of the reservoir. The tunnel is about 2.8km long. A curtain grouting whose measurements are 200m to 400m in length and at 1.5 to 12.0m intervals from one grout hole to another (Fig. 3).

Grout curtain from the grout tunnel in the ridge at the right bank of the reservoir

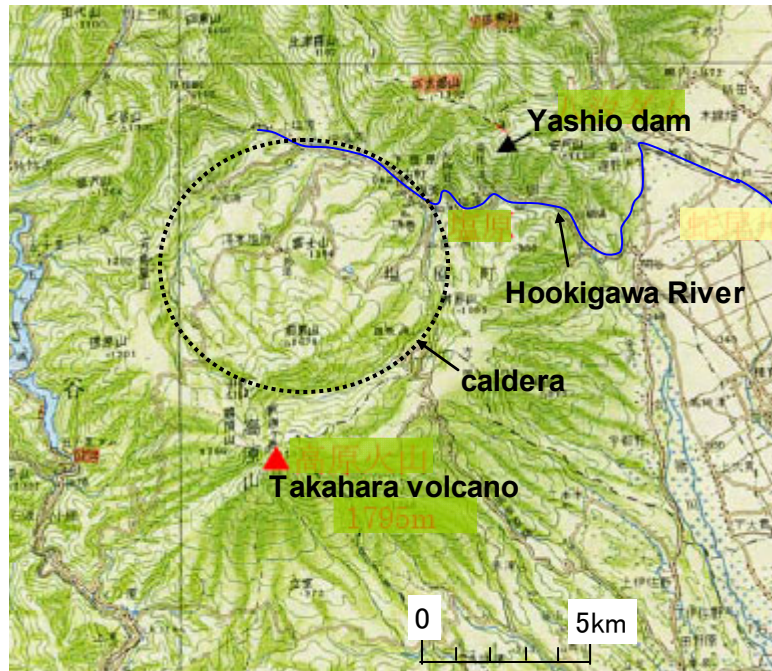
Fig.10
The Takahara volcano and the somma

We studied the processes of topography formation in the large regions and the causes of unloading at the right bank of the reservoir. We can see that the reservoir of the Yashio dam is at the outer rim of a volcanic crater which is in the north direction of the Takahara volcano on the topographical map at a scale of 1:200,000 (Fig. 10). We found the sediments of the pyroclastic flow at a part of the ridges of the right bank of the reservoir and the ridges around the caldera. We estimated that the area was comprised of level ground, but after the eruption of the Takahara volcano, the caldera was formed. After that, ejecta piled up on the north side of the Takahara volcano and the deposits piled up on former Lake Shiobara due to multiple eruptions of the Takahara volcano. The water level of former Lake Shiobara rose with the deposits, and water seeped over the edge of the Eastern part of the caldera. After that, the Hookigawa River formed and the caldera wall and both banks of Hookigawa River were rapidly flooded. We estimated that the process of formation of topography around the Yashio reservoir caused the unloading of the right bank of the reservoir (Fig. 11). It was estimated that the caldera was formed about 300,000 to 500,000 years ago based on age measurements of ejecta (by K-Ar method 1)). Further it was estimated that Hookigawa River was formed about 20,000 years ago by the analyzing of the volcanic ash of the Deposits in former Lake Shibara 2).

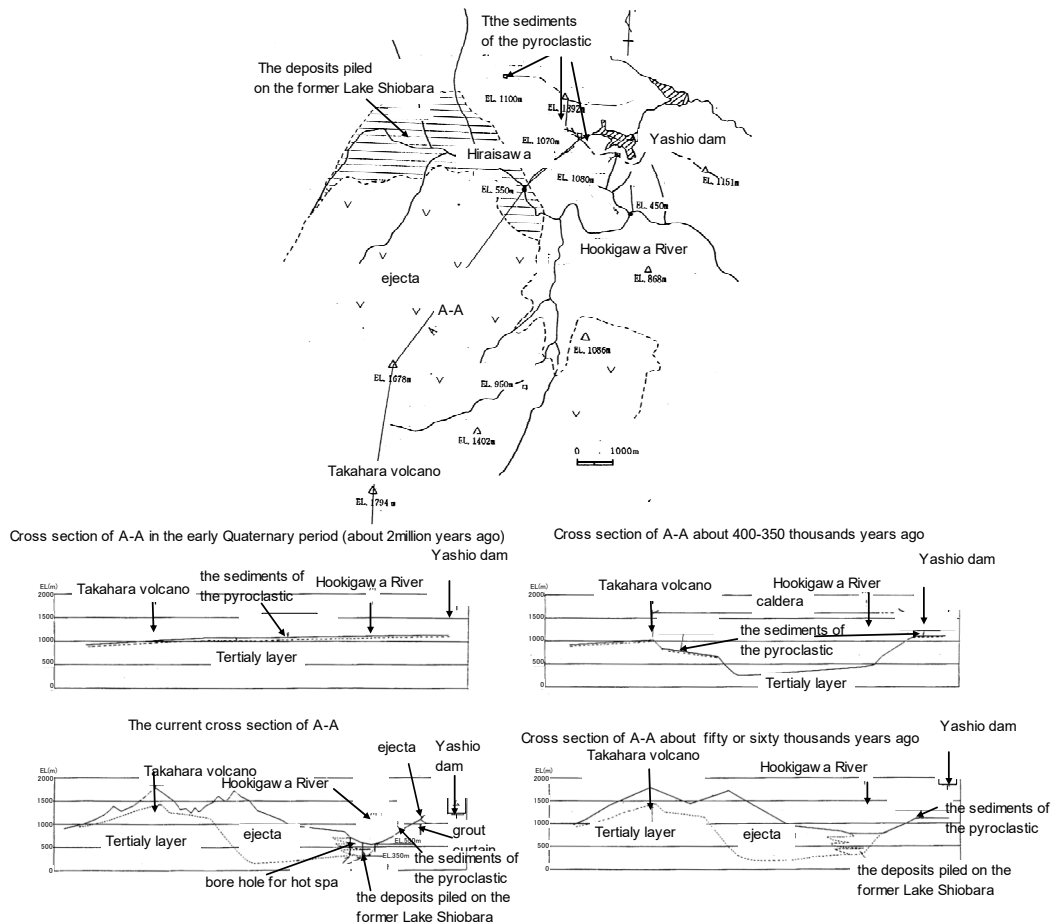
Fig.11

- (a) First, a network of the fissures was created by hot water from deep underground.
- (b) Second, a major creep occurred at the edge of the caldera created by a volcano near the dam site and that the creep developed by encroaching. The widths of the fissures were extended by the creep and the network of the fissures was formed deep underground.

History of the topography formation in the large regions around the reservoir

At present, we are conducting the grouting at the bedrock of the bottom of the reservoir filled with water. We adopted this method, because we considered that it would be impossible to make a grout curtain at more than 500 m in depth, and we expected that the groundwater flow (velocity of fluid was about 4 cm/sec) brought the grout material a long distance and the leakage of grout material to the
