Damage to the Ishibuchi dam by the Iwate-Miyagi Nairiku earthquake in 2008 and seismic assessment

H. Yoshida, A. Nakamura & N. Matsumoto
Japan Dam Engineering Center, Tokyo, Japan

ABSTRACT: The Ishibuchi Dam is a dumped rock CFRD with height of 53 m, completed in 1953. During the Iwate-Miyagi Nairiku Earthquake in 2008, a seismograph installed on the crest of the Ishibuchi Dam, which was located 9.4 km from the epicenter, recorded maximum acceleration of 14.61 m/s² horizontally and 20.70 m/s² vertically. However, the concrete facing was largely unaffected, the water storage function of the dam was completely maintained, and the damage to the dam body and the appurtenant structures remained within a repairable range.

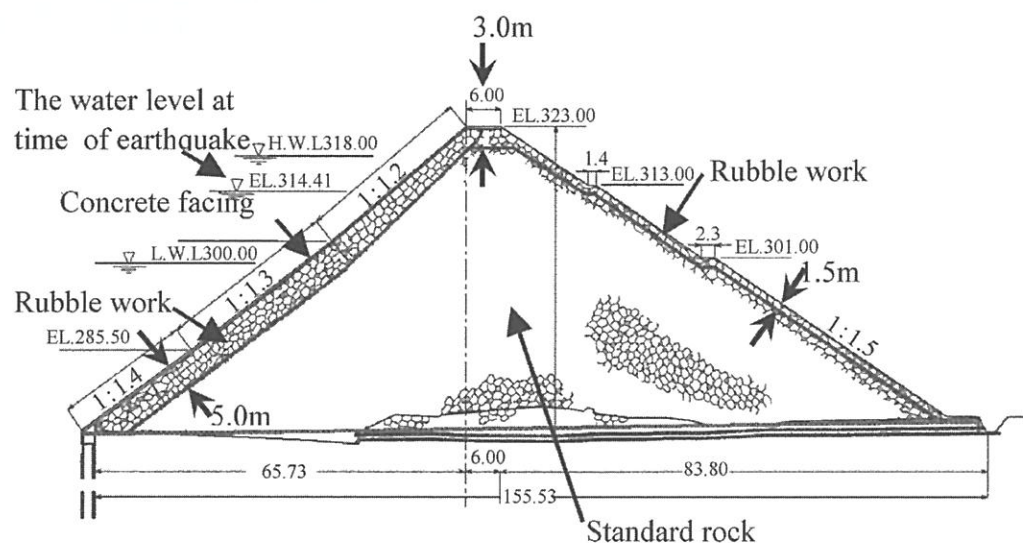
Figure 1. Cross-section of the Ishibuchi CFRD.

The concrete facing using 10 m by 10 m reinforced concrete slabs is 40 cm, 50 cm, or 60 cm thick depending on the depth of the reservoir. The upstream and downstream sides of the rock zone are made of rubble work compacted adequately to thickness of 5 m and 1.5 m, respectively. Figure 1 shows the standard cross-section.
