Long-term behavior of the Yashio dam, asphalt faced rockfill dam

T. Tsukada & M. Doi
Tokyo Electric Power Company, Tokyo, Japan

ABSTRACT: The 90.5 m high 15 year old Yashio dam, which was completed in 1995, is the upper dam of Tokyo Electric Power Company's Shiobara pumped storage power plant. There has been no leakage through the asphalt facing, and leakage through the foundation and exterior deformation of the dam body has been stable. We have measured the deformation of the asphalt facing utilizing a clinometer mounted on a vehicle towed from the crest of the dam. In addition, we have investigated the aging of the asphalt facing at the exposure test yard which was installed near the dam site on the same elevation level of the dam. We estimate that the asphalt facing was performed adequately after the aging.

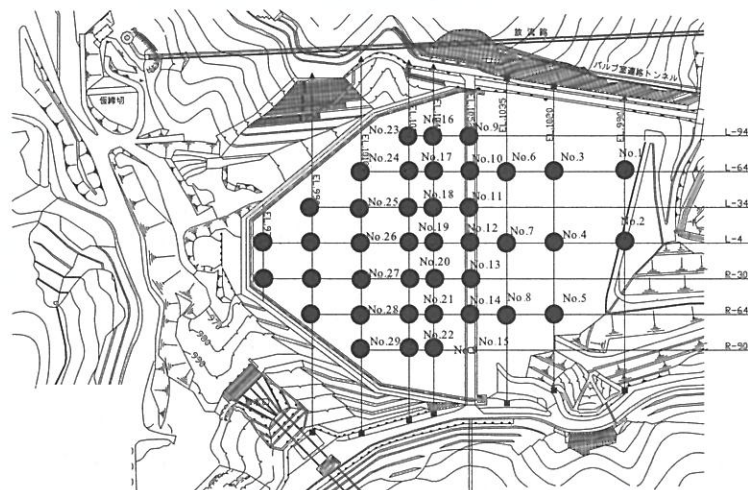
Figure 3.3. The arrangement of the external targets.

The maximum horizontal displacement towards the direction of the upstream was about 30 mm at No. 13 (near the center of the dam crest) and 25 mm at No. 3 (in the middle of the downstream at the left bank) towards the direction of the downstream. The maximum vertical displacement is about 150 mm at No. 12. We estimate that it has been stable because its increase has been 2 mm a year over the past five years. Further, we estimated that the vertical displacement near the center of the dam crest caused the horizontal displacement towards the direction of the upstream. The horizontal displacement towards the direction

of the upstream of No. 13 increased along with the water level rising in the period of the initial filling. Further, it had decreased gradually for 10 years since five or six years after the water level reached the HWL. Now that the horizontal displacement toward the direction of the upstream of No. 13 is 20 mm. Similar behavior has been shown at other points on the dam crest, and it has been evaluated that the displacement towards the direction of the upstream was caused mainly by the influence of the vertical displacement of the upstream side of the dam by hydraulic pressure. The horizontal and vertical displacements are shown in Figures 3.4 and 3.5. Further, the distribution of the horizontal displacement and the vertical displacements in the dam central cross section is shown in Figure 3.6.

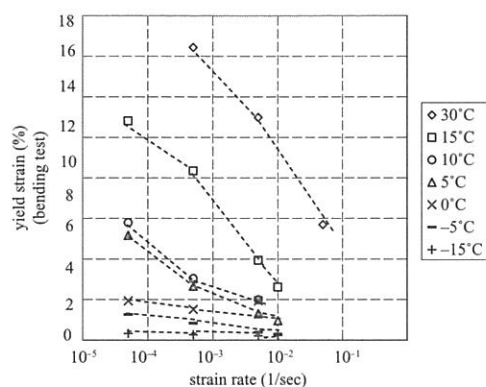
Figure 3.9. The relation between yield strain and temperature and strain rate.

The yield strain of the asphaltic concrete depends on the temperature and the strain rate. The larger the strain rate becomes, the smaller the yield strain becomes. The relation between the yield strain and the temperature and the strain rate is shown in Figure 3.9.

We estimated that the facing is stable because the calculated tensile strain is smaller than the yield strain under the test conditions of a larger strain rate at the same temperature.
