Performance of Highly Ductile Modified Asphalt for Use in Impervious Facing Zone

T. Mizuno & M. Shimazaki

Keywords: Modified Asphalt, Impervious Facing Zone, Remedial Work, Follow-up Survey

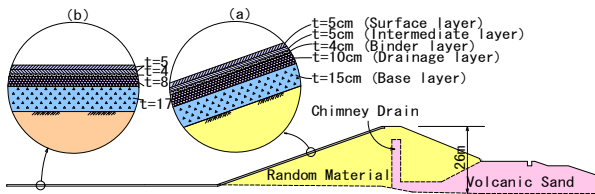
Figure 1. Dam cross-section and pavement structure

The damaged earth dam was constructed in 1971 for irrigation purpose in Shizuoka prefecture, southeast of Tokyo. Fig.1 illustrates the standard cross-section of the embankment and the pavement structures of the facing zone, the pavement thickness being 24cm along sloping surface and 14cm at the bottom of the reservoir.

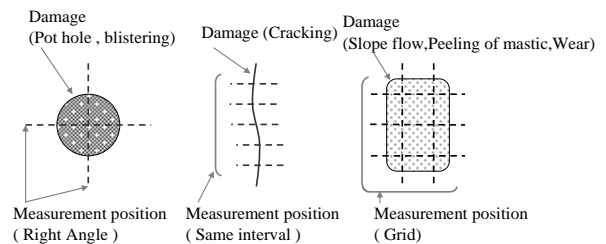
Figure 11. Measurement points of radar survey

The measurement was done in the area where damages had been detected by inspection survey, at the points of intersection of lines parallel and normal to the dam axis drawn in a specified distance, as indicated in Fig. 11.

The results of wave radar survey generally revealed satisfactory performance of the facing zone. In the northern part of the facing zone, however, some trapped water was found at a few points, between the overlaid layer and the existed pavement, where blistering had been detected in the inspection survey. This situation is considered natural, because blistering may happen under the condition that water is trapped in some reasons in the pavement as placed or in service and evaporates and expands in volume at high temperature during summer.
