Damage from Typhoon Talas to Civil Engineering Structures for Hydropower and the Effect of the Sediment Bypass System at Asahi Dam

H. Fukuroi

*Civil Engineering and Architecture Department, The Kansai Electric Power co., Inc,
3-6-16, Nakanoshima, Kita-ku, Osaka, Japan
fukuroi.hajime@a2.kepco.co.jp*

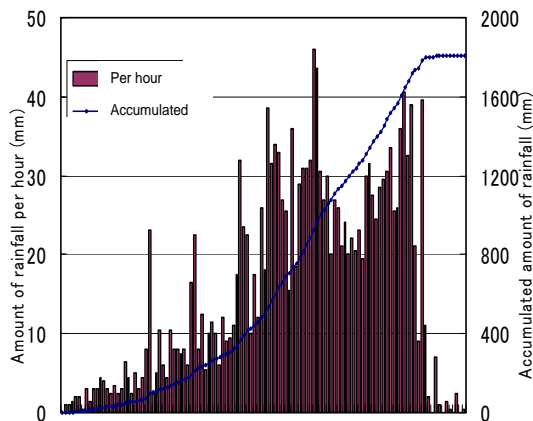
Figure 2. Amount of rainfall in Kamikitayama Village

total precipitation from August 30 to September 5 was over 1000mm. At Kamikitayama village in Nara Prefecture, the total rainfall has topped a record breaking of 1,808mm (Fig.2), according to AMeDAS (Automated Meteorological Data Acquisition System) of the Meteorological Agency. [Meteorological Agency (2011)]

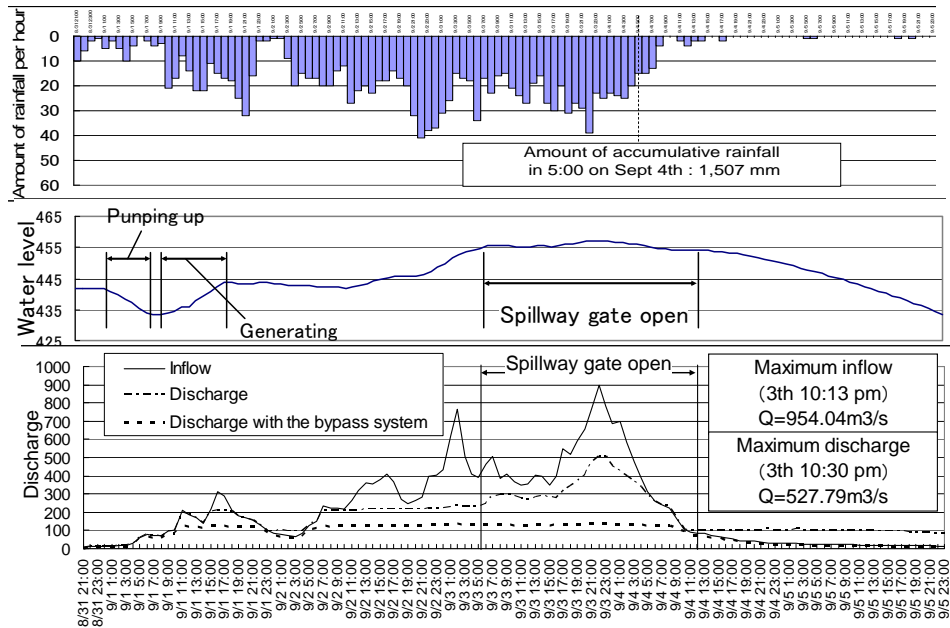
Figure 9. Operational results of Asahi Dam and the bypass system during the flood

Fig. 9 shows the operational results of the Asahi dam and the bypass tunnel during the flood of Typhoon Talas. The cumulative rainfall in the Asahi dam reached over 1,500mm and the maximum inflow to the dam amounted to 954m³/s, which surpassed by far the previous maximum inflow of 537m³/s. The sediment bypass system, which is represented as the dotted line in Fig. 9, had been operating throughout this flood period.

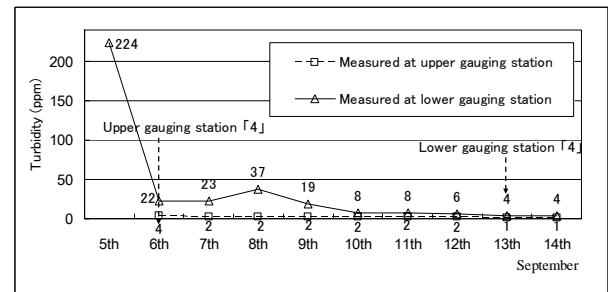
Figure 10. Data on turbidity at two gauging stations

Fig. 10 represents the measured data on turbidity at two gauging stations located upstream and downstream from the dam. The turbidity at the upper gauging station, which is located about 4.3km upstream from the dam, dropped to 5ppm on Sept 6th. And a week later, the turbidity in the lower gauging station, located about 1.5km downstream from the dam, became less than 5ppm on September 13th. The number of long-term turbidity days was similar to those in the past floods although this flood was far larger-scale.

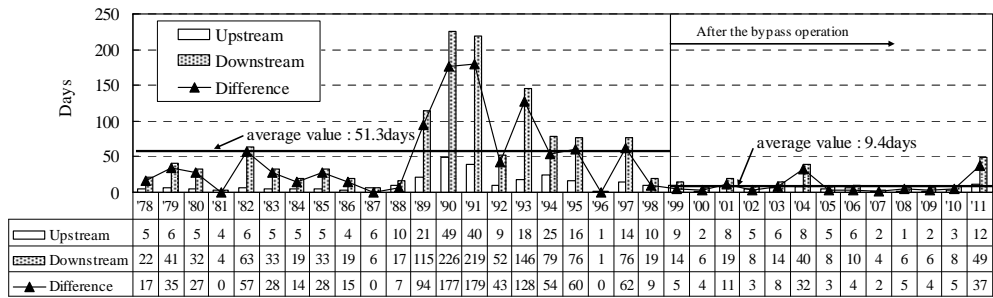
Figure 11. Number of days with turbidity over 5 ppm

Fig. 11 illustrates that the number of prolonged turbidity days has decreased dramatically from some 50 to 9 days on an annual average basis since 1998. [Harada, M., et al (1996), Kataoka, K. (2000), Kataoka, K., et al (2005), and Doi, H. (2005)] As for the definition of the long-term turbidity days, the daily data on SS over 5ppm are deemed as a day which is used for the evaluation of the prolonged turbidity and then the difference in days between the two stations is

It is clearly demonstrated that diverting a large amount of turbid water by using the bypass system is highly effective for a decrease in days for long-term turbid water discharge to the downstream area.

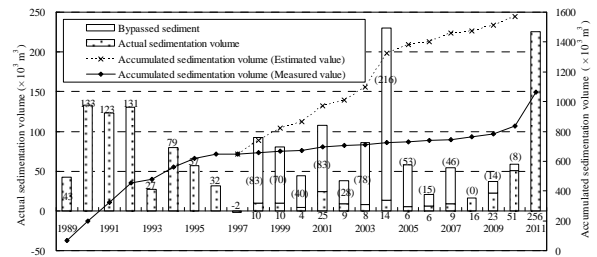
Figure 14. Measured and estimated sedimentation volume in the Asahi Dam

Meanwhile, annual measured and estimated sedimentation volumes are illustrated in Fig. 14, in which the estimated volume with the bypass operation is computed through a numerical simulation model, and the measured one is obtained through periodical bathymetric surveys. [Fukuroi, H. (2009)] Fig. 14 reveals that a range of 80 to 90 % of incoming sediments is discharged to the downstream reaches via the tunnel, and the remaining amounts deposit in the reservoir overtopping the diversion weir.

In the aftermath of this record flood, the annual sedimentation volume inside the reservoir measured more than 200,000 m³, which was the largest volume since the start of the bypass operation. Bypassed wash load and bed load during the flood period could be roughly estimated by using Fig. 15 which was developed based on the results of a numerical simulation model at the design phase. This figure indicates that about 75% of all bed load and 25% of wash load were routed through the bypass tunnel to the downstream reaches.
