# STUDY ON BEHAVIOR OF AFRD DURING EARTHQUAKE AND THE CONDUCTED REINFORCEMENT

The Yashio dam, a 90.5 m high asphalt faced rockfill dam (AFRD), holds an upper reservoir of the Shiobara Pumped Storage Power Plant (PSPP). The 2011 off the Pacific coast of Tohoku Earthquake (The 2011 Tohoku Earthquake) hit the dam and the surrounding area. The maximum acceleration values were about  $50 \times 10^{-2} \text{ m/s}^2$  (50 gal) at the bedrock and 250 gal at the dam crest respectively. Two major cracks occurred at the asphalt facing along the left and the right abutments, while the recorded accelerations were smaller than the acceleration considered at the design stage. Several studies were conducted to pursue the crack mechanism. This paper indicates that cracks may occur at the asphalt facing of AFRD if the dam structure allows strains to be concentrated at some specific facing part in the event of a strong excitation. For the Yashio dam case, we estimated that the cracks occurred in the asphalt facing due to the concentrated strains around the dam crest. The repair works of the asphalt facing were conducted with the consideration of resuming the power plant operation early, durability

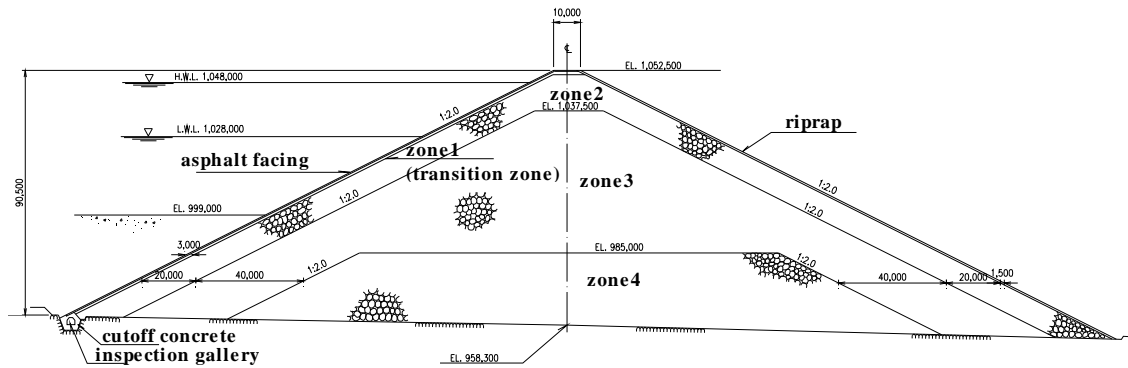
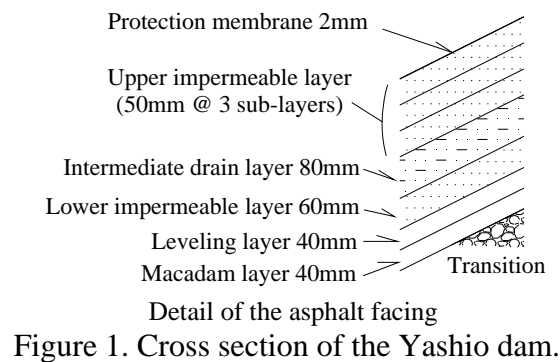
Figure 1. Cross section of the Yashio dam.

The facing of the Yashio dam consists of an upper impermeable layer, an intermediate drainage layer, a lower impermeable layer, a leveling layer and a macadam layer as shown in Figure 1. The intermediate drainage layer is set to detect water leakage in the cases of facing damages.

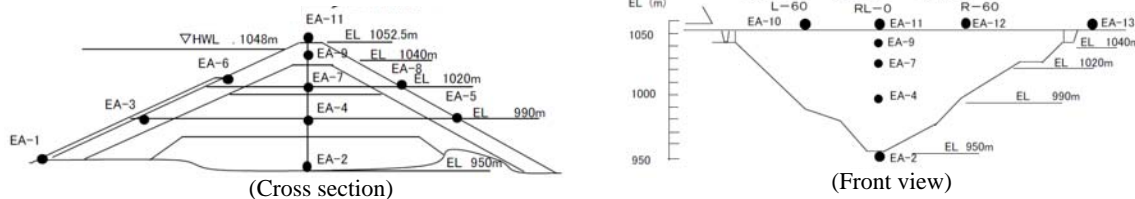
Figure 2. Location of the seismometers.

The Yashio dam is located at a 300 km distance from the epicenter of the 2011 Tohoku Earthquake. Recorded acceleration and the location of the seismometers are as shown in Table 1 and Figure 2. respectively. Two major cracks occurred in the asphalt facing due to the earthquake. This paper reports studies on behavior of the Yashio dam (AFRD) during the earthquake, estimated crack mechanism and conducted repair works.

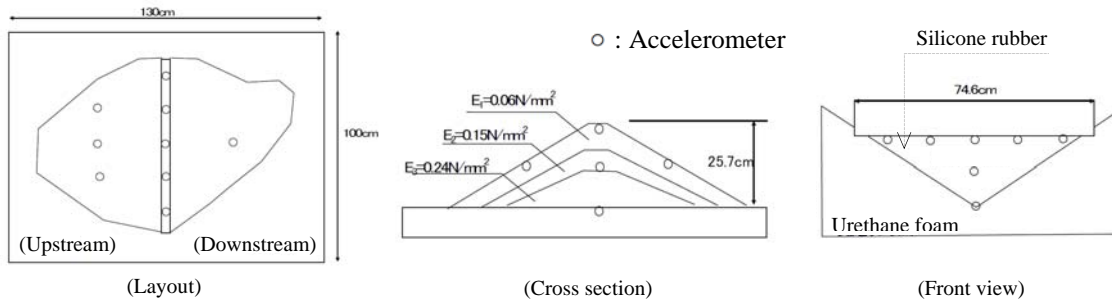
Figure 6. Three dimensional shaking test model.

Earthquake resistance of the asphalt facing was checked in the design stage by shaking tests with a 3D model as shown in Figure 6. The results of the shaking tests are summarized as follows.

The actual cracks in the facing by the 2011 Tohoku Earthquake showed similar crack propagation of the test results when shaking direction is the dam axis. However, exceeding acceleration was not dam axis direction for the actual dam behavior according to the seismometer records.

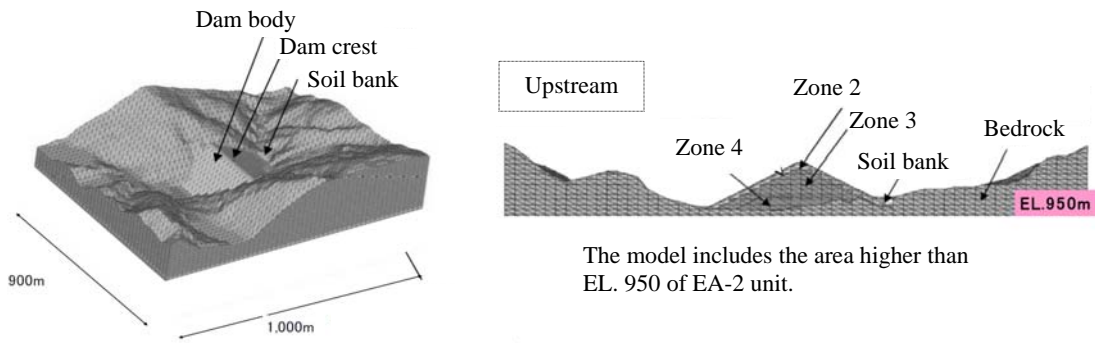
Figure 8. Three dimensional numerical analysis model.

The Yashio dam behavior during the earthquake was studied by a 3D numerical analysis, applying an equivalent linearization analysis method. The seismic wave record by EA-2 unit in the bedrock was used for the analysis. The analysis model includes the dam and its surrounding terrain as shown in Figure 8. The asphalt concrete facing was not modeled individually, assuming the facing would show same response with the dam body. Maximum acceleration and strain by the analysis are shown in Figure 9. The results of the analysis were judged as reasonable, since the calculated accelerations almost match the recorded ones although the analysis results were a little larger.

Maximum strain by the analysis was around 1/5 of the slope length below the dam crest center. Maximum values are  $1.78 \times 10^{-4}$  of tensile strain,  $1.81 \times 10^{-4}$  of compressive strain, and  $2.97 \times 10^{-4}$  of shear strain respectively. The calculated strains are small in comparison with the yield strain of the fine grained asphalt concrete of the facing, while the major cracks occurred by the 2011 Tohoku Earthquake. Further assessment was, therefore, needed to pursue the crack mechanism.
