# INSPECTION OF SUBMERGED AREA WITH THE USE OF AN UNDERWATER CAMERA SURVEY VEHICLE

1. Numata Dams Integrated Operation and Maintenance Office, Japan Water Agency, Gunma- , Japan

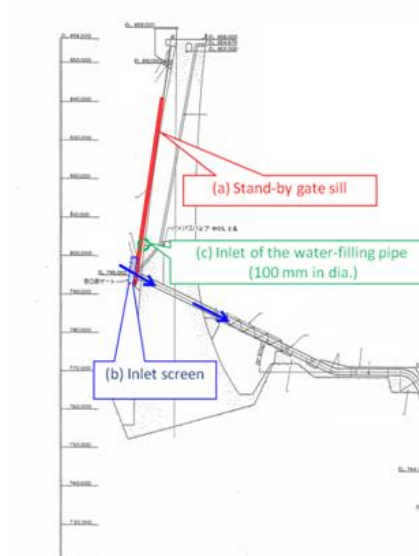
Figure 6. Inspection Point at the Yagisawa Dam (1): (a) Stand-by gate sill of the outlet conduit of the Yagisawa Dam, (b) Inlet screen, (c) Inlet of the water-filling pipe

Ordinary steel was used at (a) the guard gate sills of the outlet duct of the outlet works, (b) the water filling pipe screen, and (c) the inlet. Although tubercles were partly seen on the surface, no deformation or damage that would disturb gate operation was observed.

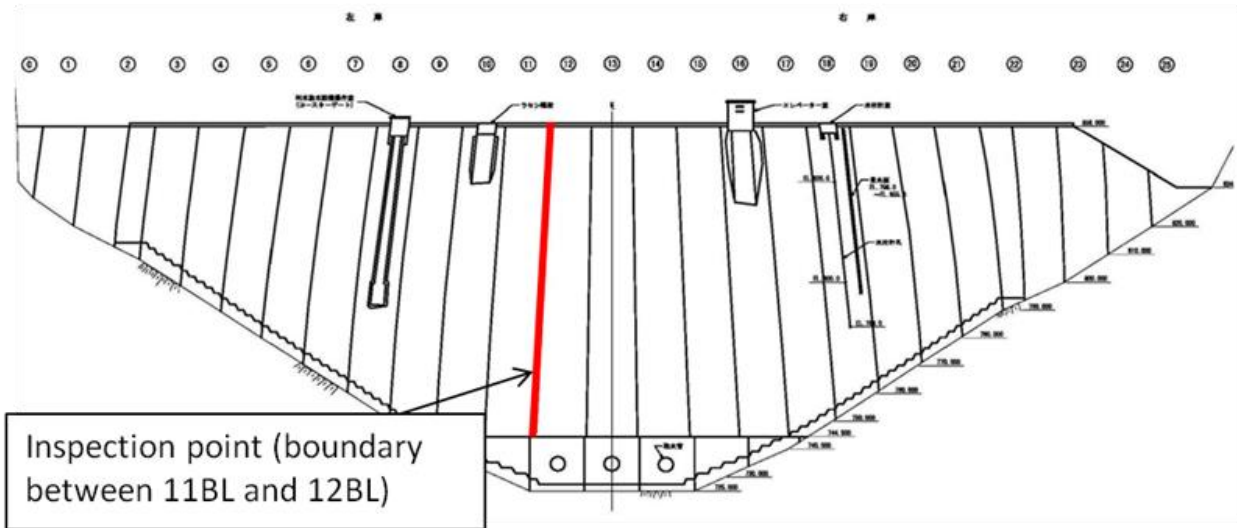
Figure 7. Inspection Point at the Yagisawa Dam (2): (d) Inspection point on the upstream side of the Yagisawa Dam body (arch dam)

The inspection of (d) the concrete of the upstream side of the dam body found cracks estimated to be minute and closed, minor flakes and rock pockets, slight peeling and leaching of surface cement paste, and exposure of rebars (not structural rebars) in the arch dam, as well as minor rock pockets and light peeling and leaching of surface cement paste in the wing dam. It is presumed that these deteriorations do not affect stability of the dam body at this moment and undergo very slow deterioration.

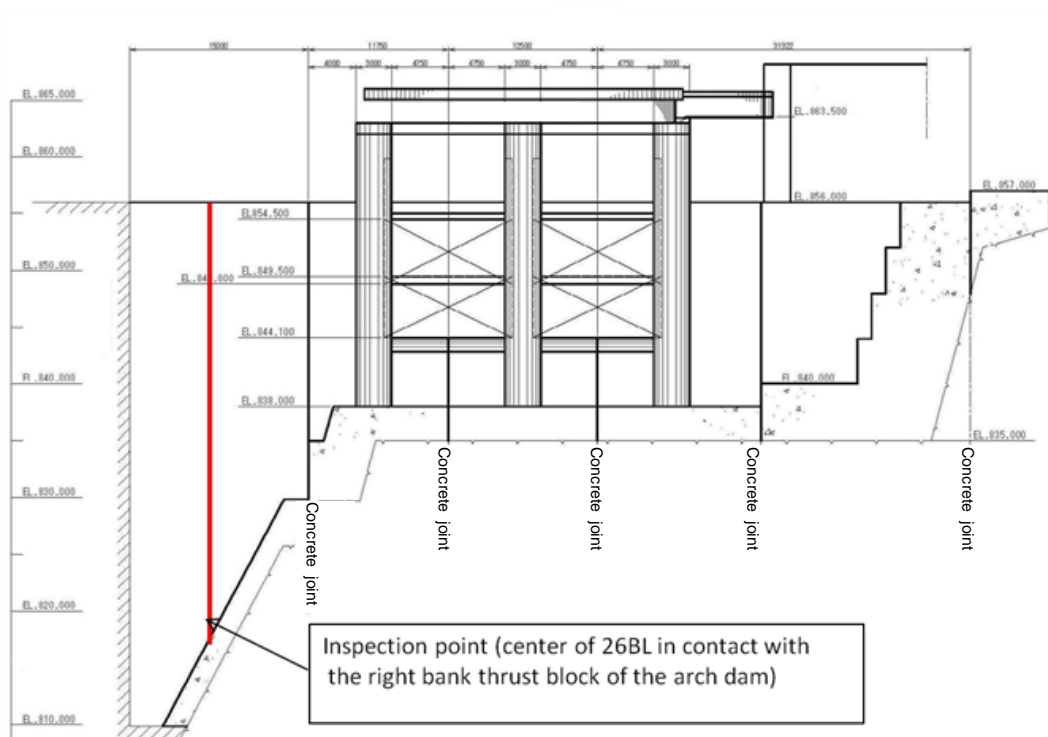
Figure 8. Inspection Point at the Yagisawa Dam (3): (a) Inspection point on the upstream side of the Yagisawa Dam body (wing dam)
