Efficient repairing and reinforcement method for AFRD damaged by the earthquake

We developed the effective repairing method for asphalt facing of the Yashio dam, asphalt facing rock fill dam (AFRD) constructed for the upper reservoir of the Shiobara pumped storage power plant of Tokyo Electric Power Company Holdings, where cracks occurred by the 2011 Tohoku earthquake, to complete repairing works in a short period so as to resume power generation immediately. The developed repairing method was consisted of asphalt mastic using asphaltic material developed for the purpose of improving deformation performance under a low temperature, hereinafter we call it “low elastic asphalt”, and asphalt impregnated non-woven sheet. We completed the repairing works in about only one month, because we limited the removing area by covering the low elastic asphalt mastic of 10 cm width and 5 cm thickness, as a buffer part absorbing the strain, on the cracks leaving in the layer underneath from the forth layer to the bottom layer of the asphalt facing consisted of seven layers. In addition, it was estimated that the cracks occurred by the strain concentration of the crest concrete block joint connect

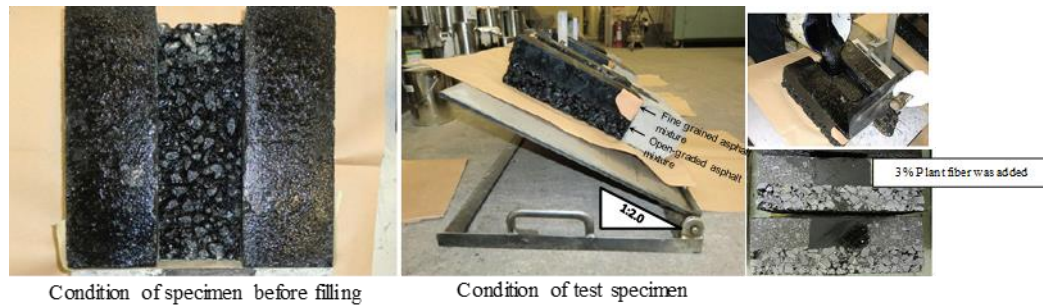
Figure 10. laboratory tests of low elastic asphalt mastic

The test results showed that there was significant flow of the mastic with no plant fiber, and that the mastic became too viscous to ensure even mixing and workability when 5% was added. As a result, a weight ratio of 3% (case3) was adopted.

For SF and filler to be used as the asphalt mastic filled into the groove of the 10 cm wide cut, the weight ratio was determined based on the compositional ratio of the asphalt mastic used in the protect layer of the existing facing wall. With regard to the mixing ratio of the flow inhibitor, it was important to set this correctly so as to avoid any degradation of drainage performance caused by flow of the material during application on a slope or entry into voids in the intermediate drain layer (open-graded asphalt mixture) lying below the point of application. Three weight ratios, i.e., none, 3%, and 5%, were tested in the laboratory, as shown in Figure 10, and the relevant ratios (case1 to case3) are shown in Table 1.

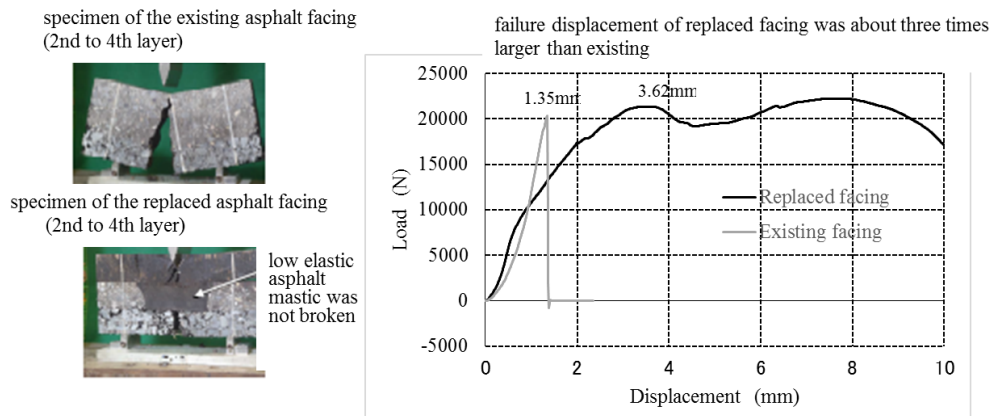
Figure 12. Results of the bending tests of repairing structure

Next, an experiment was conducted to examine the effect on a composite structure simulating the actual section to be repaired. Hence, a specimen was prepared as simulated the method used for the Yashio Dam that assuming the cracks were left. Then the bending test was conducted assuming that the left cracks will open in the layers below the intermediate drain layer. Since it constitutes a relatively thin membrane with respect to the body of the dam, the facing is assumed to behave integrally with the dam body, so that strain occurs as it follows the deformation of the dam body's upstream surface. Therefore, assuming that displacement is transmitted from the lowest layer of the facing, a bending test simulating the repairing work was conducted to confirm its ability to follow such deformation of the dam body as would open the cracks remaining in the lower layer of the facing. As shown in Figure 11, a specimen was prepared to model, in the cross-sectional direction of the facing, the second upper impermeable layer, third layer with a central 10 cm wide groove filled with SF mastic, and intermediate drain layer. Slits were created in the intermediate drain layer to simulate the cracks, and loading was applied to the center of the upper edge so that the slits would open. For comparison, the same test was conducted on another specimen simulating the existing section without slits. The resulting load-displacement curves are shown in Figure 12, and it was confirmed that no fracture occurred until the deflection reached three times that at which the specimen simulating the existing section fractured. When loading was continued further, fracture occurred in the upper part of the fine grained asphalt mixture at its boundary with the asphalt mastic, but the connection between the fine grained asphalt mixture and asphalt mastic maintained its close adhesion.

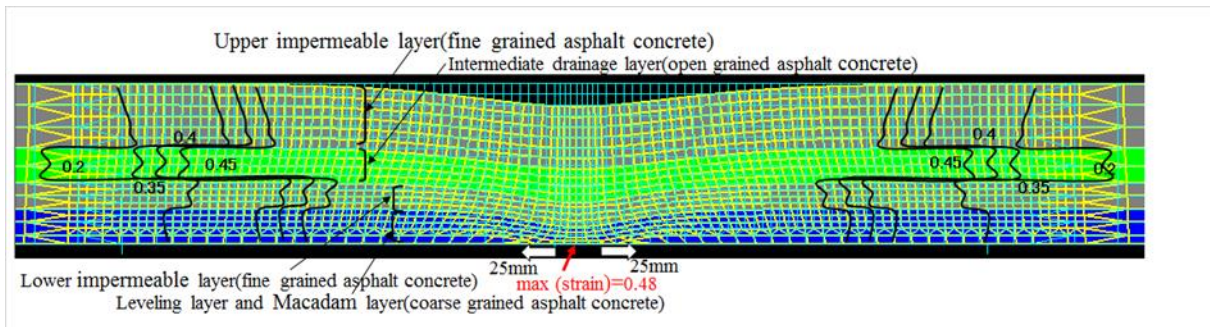
Figure 13. Result of FEM analysis (existing asphalt facing model)

With respect to the structure before reinforcement, forced displacement was applied to the crest concrete joint at the lower part of the facing near the crest in order to examine the occurrence of strain in various parts of the facing, as shown in Figure 13. White arrows in Figure 13 indicates the displacement of 50 mm at the crest concrete joint. This indicated the occurrence of a large amount of tensile strain over a wide area. However, when SF mastic was applied at the joint over a width of 100 mm as joint filler, strain concentration occurred at SF mastic, and strain in the surrounding area was reduced. Nevertheless, since strain exceeding the fracture strain (2.3×10^{-3}) of the fine grained asphalt concrete of the existing structure occurred near the boundary with SF mastic, it was judged that the area around SF mastic needed to be replaced by a material with high deformation performance. Fine grained asphalt mixture using SF—as a material with high deformation performance—was therefore utilized, due to its successful use in the Higashifuji dam and Futaba dam.

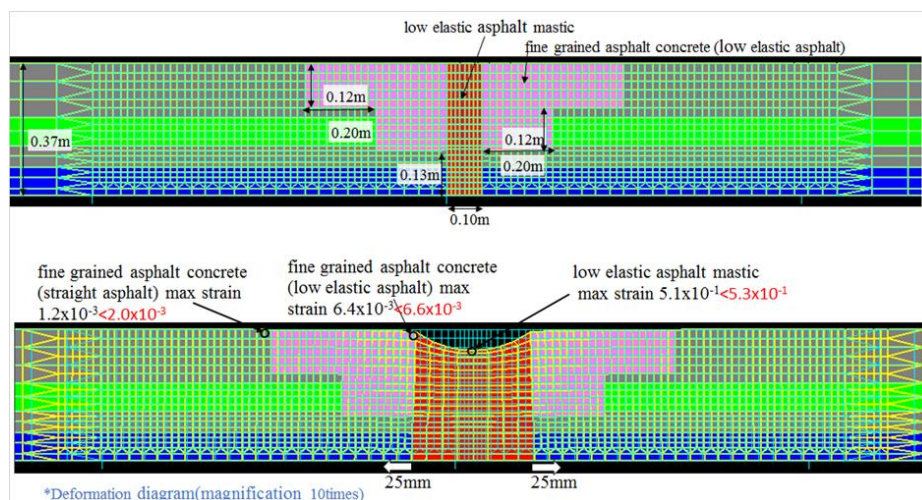
Figure 14. Result of FEM analysis (reinforced structure model)

Whilst changing the regions over which replacement with fine grained asphalt mixture using SF is performed, elastic analysis with 2D FEM was conducted in order to investigate the strain distribution in the facing caused by displacement of the opening (50 mm) at the joint. The results showed that when SF mastic was applied over a width of 100 mm at the upper part of the joint and an area of 400 mm on each side of this 100 mm width was replaced by fine grained asphalt mixture using SF, the resulting strain did not exceed the fracture strain of either material, as shown in Figure 14, and the design was shown to be capable of following tensile strain of up to 50% in the asphalt mastic section.

The physical properties assigned to each material in the analysis are shown in Table 3. The reinforcement structure near the crest concrete of the Yashio Dam, developed based on these analysis results, is shown in Figure 15. As explained above, use of SF as joint filler achieves the capability to follow strain of up to 50%, and so may be regarded as useful in the construction of new dams of the same type or as a method of improvement for existing dams of the same type in which there is a concentration of strain.
