Study on scouring phenomena at downstream of dam during flood control

Yuichi Kitamura^{1,a}, Shingo Takagi^{2,b}

¹*Chigasaki Research Institute, Electric Power Development Co., Ltd. (J-POWER), Kanagawa, Chigasaki, Japan*

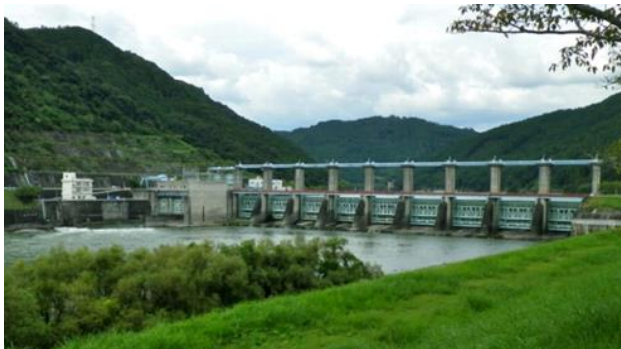
Figure 2. Funagira Dam

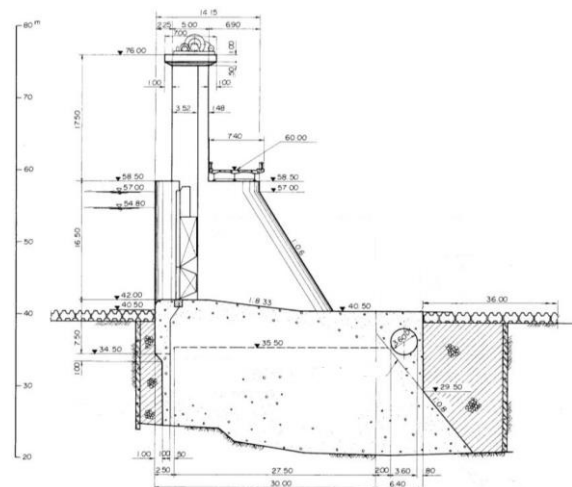
Figure 3. Standard cross section of Funagira Dam

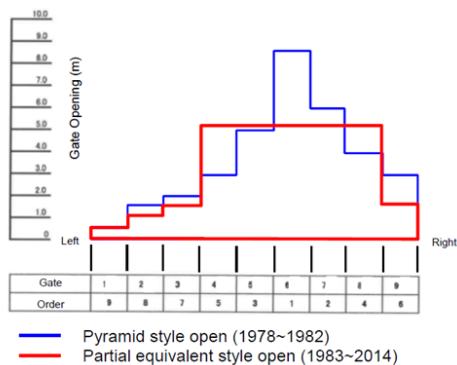
Several floods were discharged from the gates after the dam was completed. The discharging style was like a pyramid style opening gate (hereinafter pyramid opening) during 1978 and 1982. After two large floods, we changed the gate operation in a semi uniform opening in 1983 (Figure 10). Even in the case of following this semi uniform opening, the rates of water discharged on both left and right sides differed. This opening still generated a plane horizontal swirl flow in both the left and right areas downstream of the gates from which no water were discharged (dead water region). We did not take account this phenomena at that time referring to the report of J-POWER (1990).

Figure 10. Pyramid and semi uniform opening gate for until 3,000m³/s

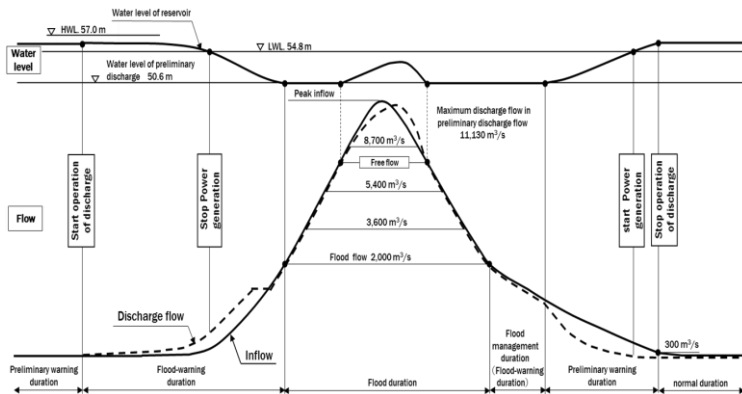
built up and kept relatively stable with a discharge in a range from approximately 7,200 m³/s to 8,000 m³/s in the model. However, the discharge exceeded 8,000 m³/s that leads free flow with all the gates full opening. It is shown in the discharge operation of Funagira Dam in Figure 16. This period lead the scouring in front of Gates 1 to 4 and of Gate 9 at the foot of emergency measures. Particularly, the left and right banks were largely scoured (downstream of Gates 1, 2, and 9) (Figure 17), referring to the report of J-POWER (2014).

Figure 16. Flood operation of Funagira Dam

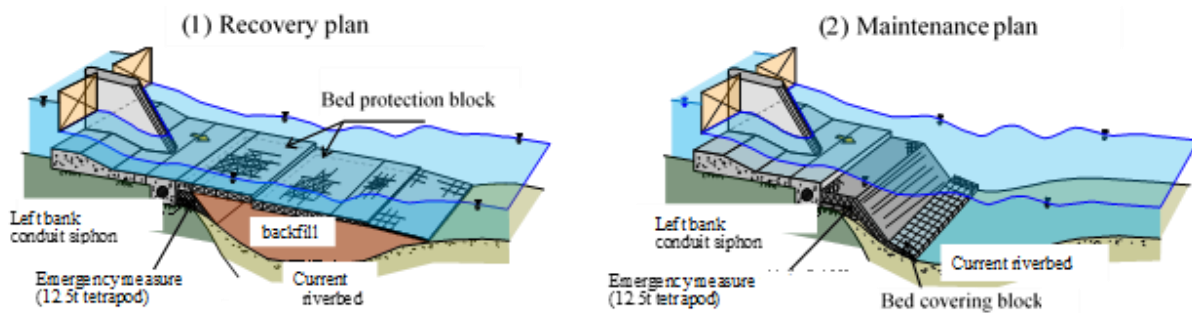
Figure 18. Recovery plan and maintenance plan of long term measures

We have studied to establish long-term measures. They were two measures. One is a “riverbed recovery plan (hereinafter recovery plan)” that is putted back to the original riverbed with bed protection blocks. The other is a “riverbed maintenance plan (hereinafter maintenance plan)” that is carried out reinforcement by blocks on the current riverbed after the emergency measures were taken. Through the study, we took into account the present situation where the downstream water level is lowered. We focused on how the long-term measures can be comprehensively satisfied including management. Figure 18 shows the recovery plan and the maintenance plan.

The maintenance plan has finally been chosen as a long-term measure. This plan planned also the shorter construction period, too. The construction has started in October 2015, and second period has started in September 2016 and it will be finished in May 2018.

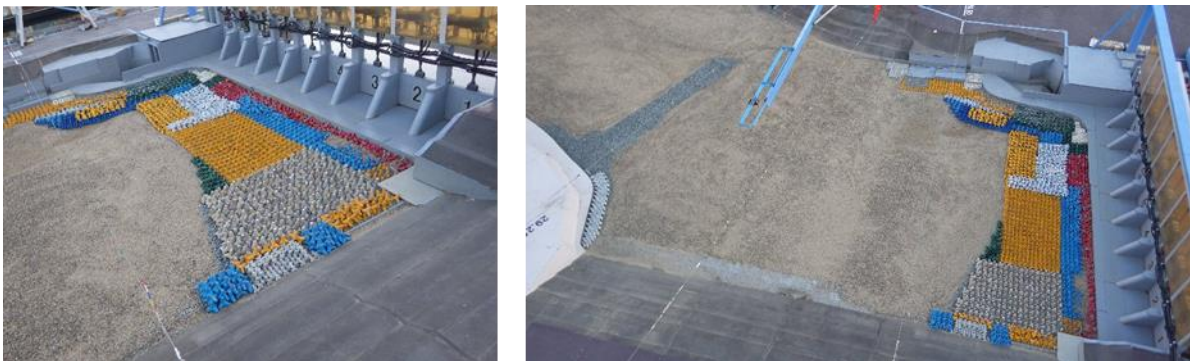
Figure 21. The latest long-term measures in front of Funagira Dam

- To establish of management standards stipulating those including allowable of sediment along the right bank, and height of the riverbed around the river wall along the left bank
- To control of the riverbed by removing of sediment excessively deposited along the right bank, supplying sediment around the river wall on the left bank
- To displace of the river wall itself with implementation of regular inspections, and to reinforce of the river walls on the both side of banks by increasing the width of the consolidation work

The tests were carried for establishing of management standards, and the maintenance plan was modified to be more stable. Figure 21 shows the latest long-term measure design. The field observations of morphological changes is important at the downstream of the dam. Figure 22 shows the morphological change of the riverbed in front of Funagira Dam after starting the uniform opening gate of water discharge on June 2014, referring to the report of J-POWER (2016).
