# Inspection of construction joints in the concrete dam body by the impact elastic wave method

Shigeki Ichikawa<sup>1,a</sup>, Toshiro Kamada<sup>2,b</sup>, Tomonobu Sugiura<sup>3,c</sup>, Naoyoshi Hayashi<sup>4,d</sup>

<sup>1</sup>*Dam Engineering Division, Water Resources Engineering Department, Japan Water Agency, Saitama, Japan*

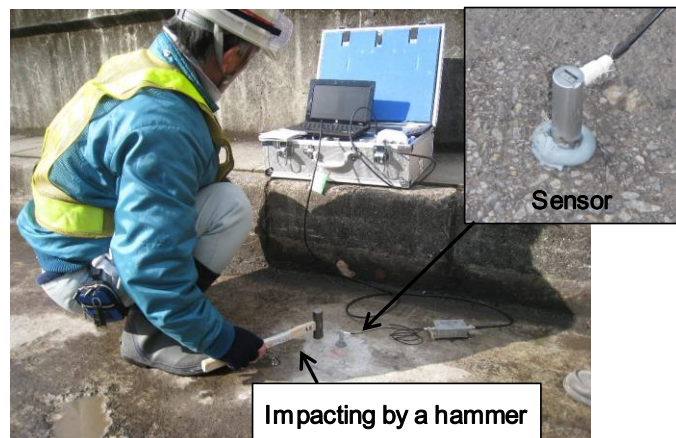
Figure 3. Measurement on the dam crest

Figure 3. shows a photo in which an impact is applied to an impact point on the dam crown followed by measurement of the reflected wave. Figure 4. schematically shows the relative positions of the impact points on the dam crown, horizontal construction joint for which the state will be estimated, and the state estimation points. An impact is applied at each point on the crown and the reflection wave is detected, providing information from the point on the joint faces just below the impact point.

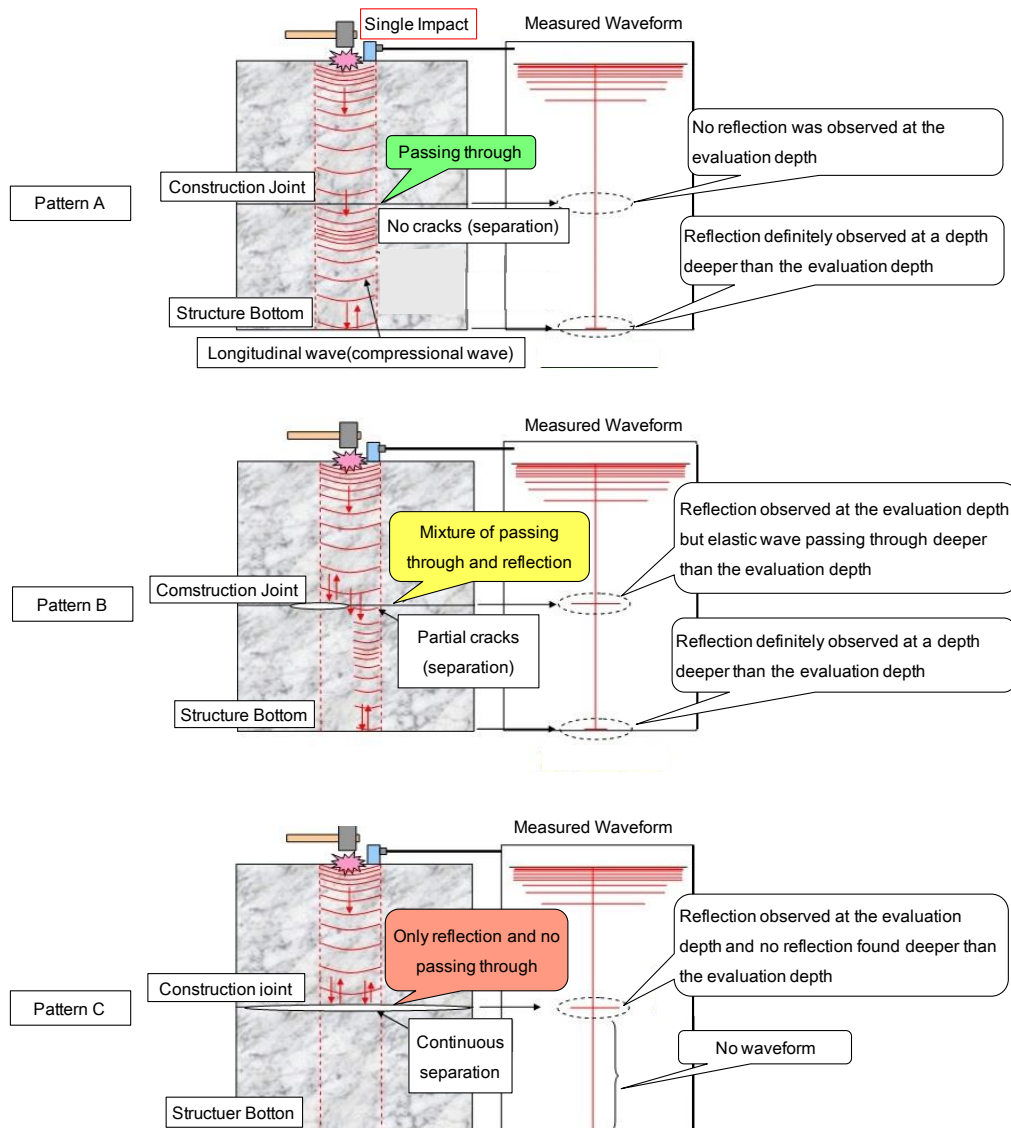
**Figure 5. Measured Waveform Patterns**

Figure 5. shows IEWM and measured waveform patterns. The measured wave, with attention focused on a certain depth, i.e. the depth to the construction joint, can be classified into three patterns as shown in figure 5.: Pattern A, in which the wave was not reflected at the assumed depth but mostly passed through at that level (a reflection was observed at a deeper level); Pattern B, in which the wave was reflected at the assumed depth but which also partly passed through at that level (another reflection was observed at a deeper level); and Pattern C in which the wave experienced a definite reflection at the assumed depth (no reflections were noted at deeper levels). Pattern A is estimated to indicate a state in which no degradation such as cracks exists at the assumed depth that reflects the elastic wave. On the other hand, Pattern C suggests the occurrence of degradation including cracks that do not carry the wave. Pattern B shows the presence of sections of degradation, which reflect the elastic wave, as well as other sections that transmit the wave.
