# A Study on Sedimentation Processes in Takase Dam Basin

## Abstract

**Key Words:** *Takase dam, mountain river basin, sediment production, transportation, deposition*

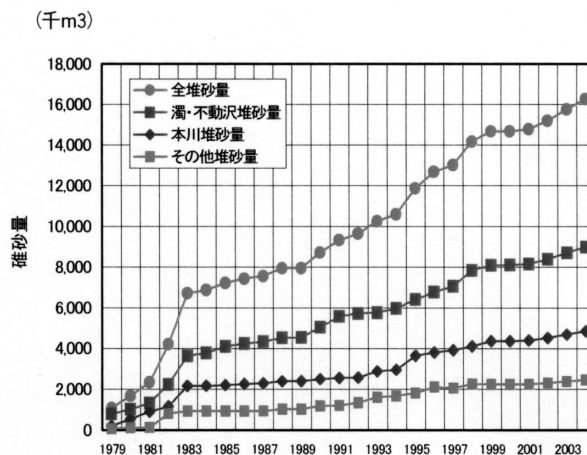
Fig. 2 The volumes of sediment deposited in Takase reservoir

Of the 16 200 000 m<sup>3</sup> sediment, 4 800 000 m<sup>3</sup> came from the Takase River, 8 900 000 m<sup>3</sup> from the Nigorisawa-Fudosawa rivers and the remainder from other streams (Fig. 2). The specific sedimentation rate, which can be obtained by dividing the total volume of sediment deposited by catchment area of 131 km<sup>2</sup> and then by 26 years elapsed, is 4 750 m<sup>3</sup>/km<sup>2</sup>/year.

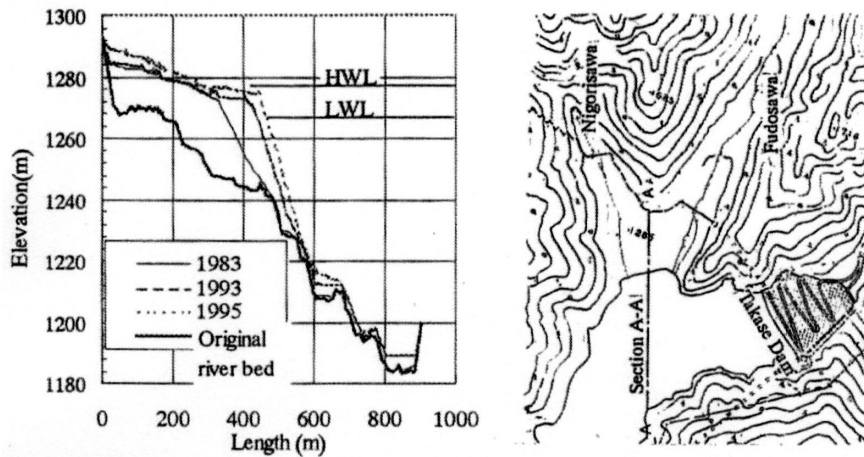
Fig.10 Changes in pattern of deposition at entrance to reservoir (section A-A)

Changes in the pattern of deposition at the entrance to the reservoir are shown in Fig. 10.

Results indicate that the riverbeds upstream of the reservoir have a tendency to rise under the influence of the reservoir.

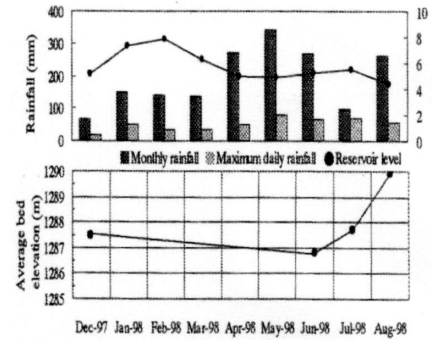
Fig. 13 Seasonal changes in river bed elevation in Fudosawa alluvial fan

Fig. 13 shows average changes in the elevation of the riverbed in the alluvial fan section of the Fudosawa during the period from December 1997 to August 1998.

According to Fig.13, during the winter-snowmelt season from December to June, the riverbed became lower, because of scouring due to supply of less sediment loaded flow from upstream. Later, in the summer month of July, the trend was reversed and the riverbed began to rise.
