VINGT SIXIÈME CONGRÈS
DES GRANDS BARRAGES
Vienne, Juillet 2018

**HISTORY AND PRESENT STATE OF INVESTIGATIONS ON
LANDSLIDES CAUSED BY RESERVOIR FILLING: A REVIEW***

Yasuhiko WAKIZAKA
Director of the Research Department II, JAPAN DAM ENGINEERING CENTER

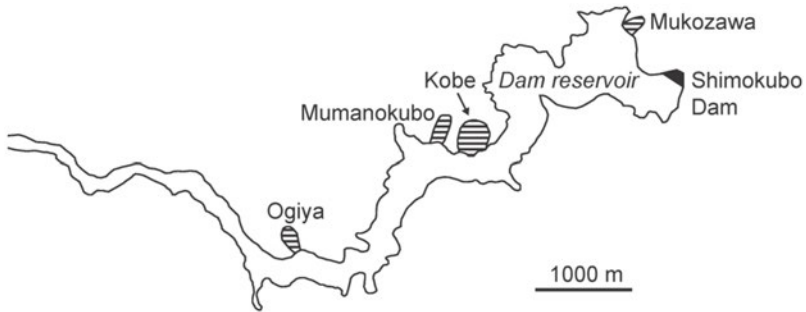
Fig. 5
Distribution of reservoir landslides at the Shimokubo Dam. Based on TAMADA [3].
Répartition des glissements de terrain dans le réservoir du barrage de Shimokubo. Basé sur TAMADA [3].

The Shimokubo Dam was completed in 1968. According to TAMADA [3], the state of the reservoir landslides were as follows. First reservoir filling began on November 24, 1967, and 13 landslides were investigated before the first reservoir filling from 1959 to 1968. The investigations consisted of seismic exploration, electrical exploration, well logging, drilling, permeability testing, ground water logging and soil tests. Based on results of these investigations, countermeasures were made in four landslides which were assumed to affect houses and roads. The reservoir water level reached 292.4 m above sea level in early April 1969, but no landslide moved until this time. Then the reservoir water level was fallen until it reached 250.12 m above sea level in the middle of June. Cracks and collapses occurred in the Kobe, Mumanokubo and Ogiya landslides from late May to late June (Fig. 5 and 6). Drilling, ground water logging and movement observations were performed at these landslides. It was assumed that these landslides were caused by residual pore pressure, then drainage wells and borings and steel pipe piles were constructed. The reservoir water level was kept above 290 m above sea level from October 1971 to June 1972. When the water level was only risen in 1972, a landslide occurred in Mukozawa. Eight drilling and movement observations were done. Drainage borings and steel pipe piles were constructed as countermeasures. Surface intake facilities were constructed in the Shimokubo Dam from 1975 to 1978. The reservoir water level had to be lowered 80 m during this period to execute the construction; the water level was reduced by 60 m

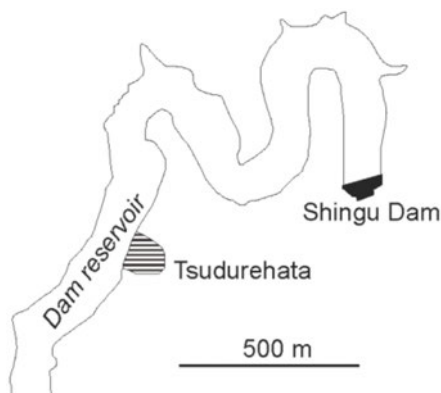
Fig. 7

Distribution of reservoir landslides at the Shingu Dam. MORIKAWA [4].
Répartition des glissements de terrain dans le réservoir du barrage de Singu.
Basé sur MORIKAWA [4].

The Shingu Dam was completed in 1974. Its geology is Sambagawa meta-morphic rocks consisting mainly of psammitic schist with thin layers of basic and pelitic schists. The road surface cracked in May 1976 in Tsudurehata (Fig. 7).
