<p>COMMISSION INTERNATIONALE DES GRANDS BARRAGES ----- LA 78^{EME} CONGRES DES GRANDS BARRAGES <i>Hanoi-Vietnam, may 2010</i></p>	
---	--

DESIGN OF FOUNDATION TREATMENT (CURTAIN GROUTING) AT OYAMA DAM

Toshiro MAEDA
Construction Division, Oyama Dam Construction Office,
JAPAN WATER AGENCY, JAPAN

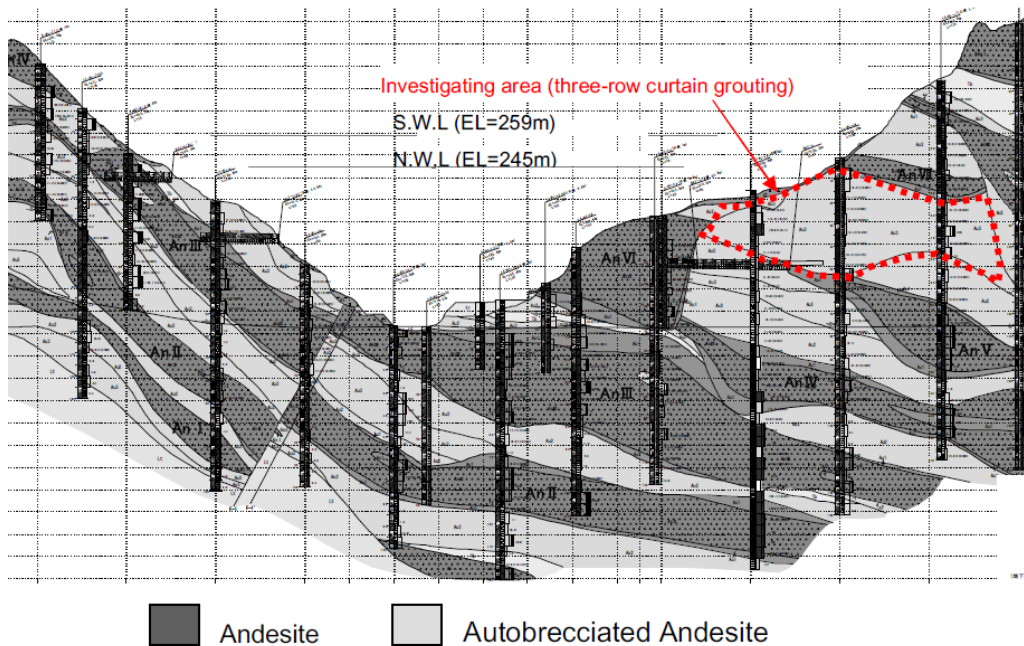
Fig.2

Geological cross section at dam axis

While the geology in superficial part of the right bank slope in which three-row curtain grouting is constructed shows thickly deposited CL-class autobrecciated andesite of type 3, other layer of autobrecciated andesite is mainly

classified as CM-class, indicating their different features (Fig. 2).

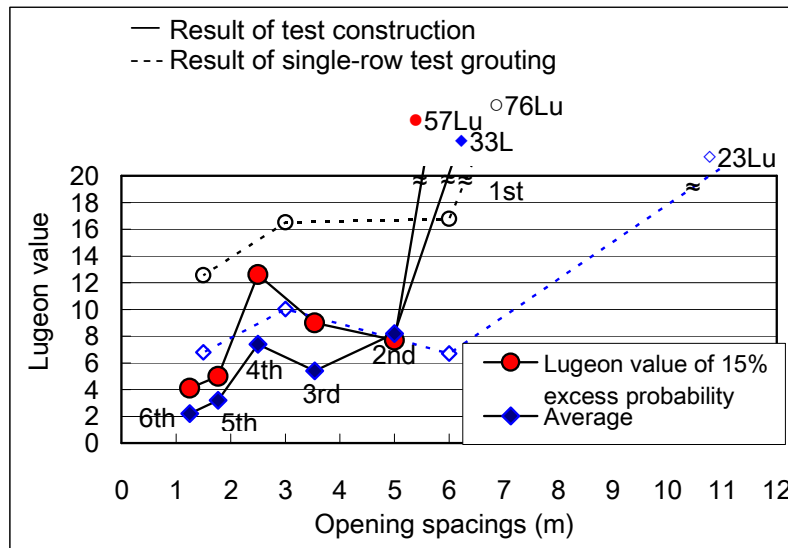
Fig. 8
Relation between opening orders and Lugeon value

Early permeability (primary holes) was 57 Lu (exceedance probability is 15%: same as followings) as a whole. The permeability was reduced to 7.7 Lu at the stage of secondary holes; about 10 Lu from tertiary holes; about 5 Lu at fifth openings (opening spacings: 1.77 meters) (See Fig.8).

When it was compared between 0-H/4 (1-5 stage) area and H/4-H/2 area (6-8 stage) (See Table 4), both areas were interpolated from 10 meters lattice up to fifth holes (opening spacings: 1.77 meters) in succession and Lugeon value was reduced to about 5 Lu at exceedance probability of 15% value.

The relationship of holes distance and Lugeon value to cement content under the test construction with use of lattice-shaped arrangement is shown in the preceding chapter, Fig. 8 and Fig. 9. Both Lugeon value and cement content reduced significantly at secondary holes, but decreasing trend was not seen at second to fourth holes. The values in construction after fifth holes resulted in

When considering the lowering trend of Lugeon value (Fig. 8) together, most of fissures of matrix part at secondary holes are filled up and fissures of matrix part are distinguished in the area with high permeability of 20 Lu or more. In addition, construction up to 1.77 m lattice results in improvement to 5 Lu by filling up the fissures in andesite block and matrix. The fissures of matrix part do not increase by constructing 1.77 m or narrower lattice, showing the same trend as in Lugeon value. It is considered that permeability in this geology with 5 Lu or more is mainly caused by the fissures of matrix part. On the other hand, it would appear that the fissures of andesite block are not continuous and influence on water permeability is small.

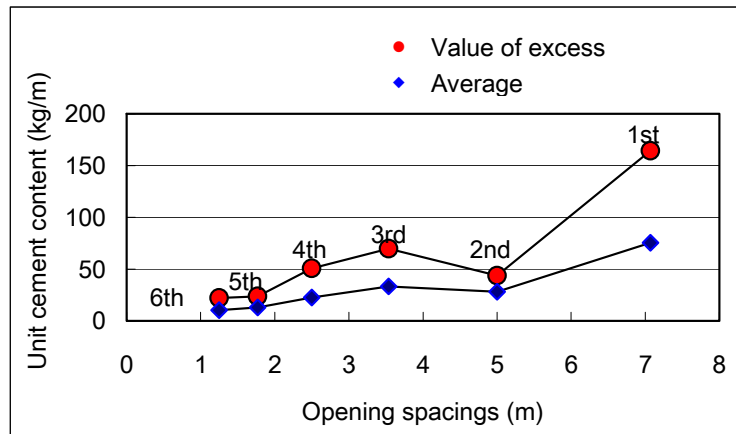
Fig. 9
Relation between opening orders and unit cement content

As shown in Fig. 9, unit cement content was 75.5 kg/m at primary holes (average value: same as followings) and reduced to 28.2 kg/m at secondary holes. It increased slightly at tertiary holes to reduce gradually after that, resulting in 22.7 kg/m at fourth holes and 12.8 kg/m at fifth holes.

When 0-H/4 area (1-5 stage) was compared to H/4-H/2 area (6-8 stage), unit cement content was stable after secondary holes, although high injection stages were seen after fourth holes for 0-H/4 area (1-5 stage); at fourth holes for 0-H/4 area (1-5 stage).

About 50% of primary holes and 70% after secondary holes were injection at below 20 kg/m.

Specified injection pressure has low critical pressure, but initial specified pressure is injected in hope of improvement effect because there is not much unit injection cement content in Fig.9.

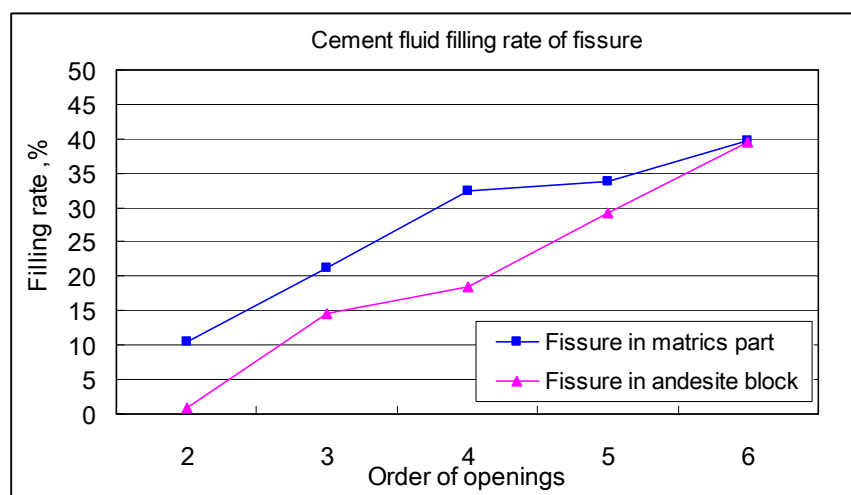
Fig. 13
Cement fluid filling rate of fissure

As shown in Fig.13, as for the filling rate, fillings into matrix are mainly verified in low order level, while many fillings are seen in andesite block as opening spacings narrow.

This result is believed to be due to the difference between the both continuities of fissures. In other words, as the fissure of andesite block continues only in its block, filling rate lowers because there is a low probability of continuity of fissure between filling holes and observation holes when the distance between holes is long. On the other hand, it is considered that high-angle fissures in matrix part are relatively rich in continuity and more cement fluid can be filled even where the distance is long.

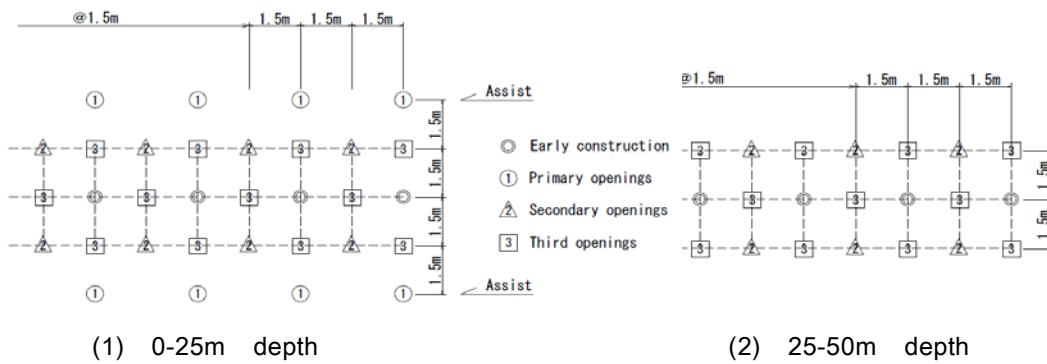
Fig. 15
Placement of curtain grouting at R-2

The placement of openings is shown in Fig.15.
