Foundation Treatment Work in the Oyama Dam Based on Hydrogeological Features

Oyama Dam is a concrete gravity dam, which is 94 meters high, 370 meters in crest length, 19.6 million cubic meters in storage capacity, located in the Chikugo River system in northern part of Kyushu. Construction of dam body works began in April 2007, and then a first impoundment has started since May 2011. Geological composition of the dam site and its neighboring area includes Pliocene of Neogene to Pleistocene volcanic rock and volcanoclastic rocks. It features the complex geological structure that is characteristic of areas covered with relatively new terrigenous rocks. Particularly foundation rock of the dam consists mainly of the Shakadake volcanic rocks formed three to four million years ago, and which are categorized into two types. One is andesites which are hard, but have many cracks, the other is autobrecciated andesite which is soft, but has few cracks. These two types of geology are distributed from left bank upstream to right bank downstream, appearing alternately in strata. The foundation rock of the dam also has a complex hydrogeological structure, therefore a foundation treatment work an

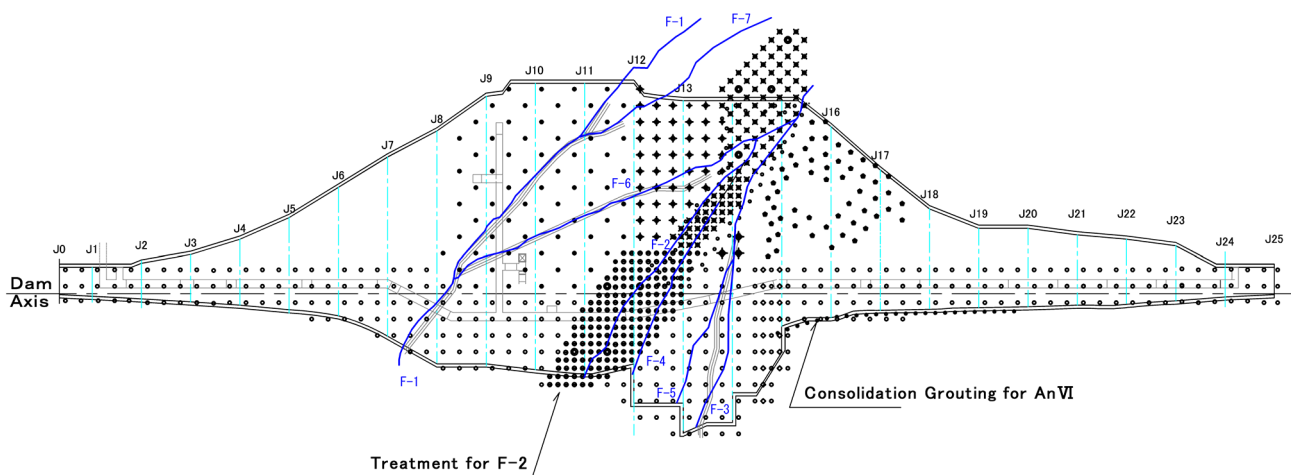
Figure 7. Locations of standard holes for consolidation grouting

carried out verifying validity and was completed in April 2011. Fig. 6. and Fig. 7. show range of curtain grouting and consolidation grouting. Table 4. shows the constructed results of grouting.

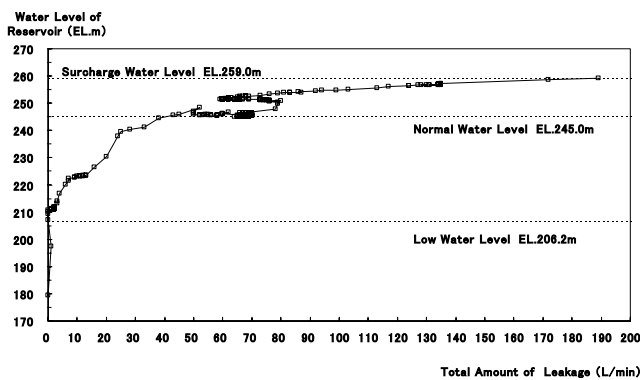
Figure 8. Relationship between water level of reservoir and amount of leakage

First impoundment of the Oyama dam has started since May 10th 2011. Fig. 8. shows a progress of amount of leakage as of March 2012. The dam is safe enough to storage water so far and it has not been a serious situation where an addition grouting is needed. First of all, the test ponding is made to complete safely, and it endeavors to provide a utility of the dam as soon as possible.
