# **Rationalizations of Curtain Grouting for Dams Based on the Revised Grouting Guidelines in 2003 in Japan and Their Evaluation**

**H. Satoh & Y. Yamaguchi**

*Public Works Research Institute, Tsukuba, Japan*

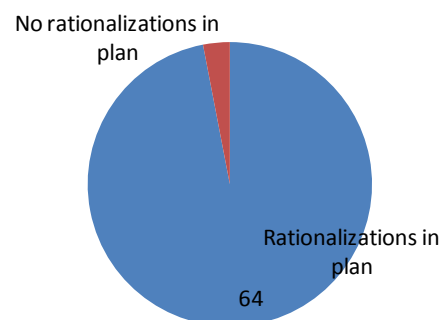
The number of dams with rationalizations in plans for curtain grouting in 66 dams with rationalizations is 64 in Fig.3. Plans of curtain grouting are often changed considering the results of previous executed curtain grouting because 2003 Grouting Guidelines recommend review of grouting plans during execution.

Figure 3. The number of dams with rationalizations in plan for curtain grouting in 66 dams with rationalization in Fig.2.

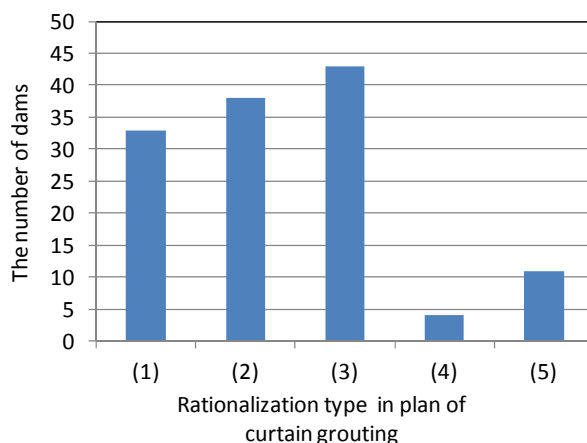
Figure 5 shows the number of each rationalization type in plan, (1) to (5) described above. Because sometimes a dam takes several rationalization types in plan, the total number of Fig.5. is more than the total number of dams with rationalization in plans. From Fig.5., we find that many dams take mainly three rationalization types; changes of curtain grouting area, changes of improvement target Lugeon values and changes of final order of design holes.

**Figure 5.** The number of each rationalization type in plan for curtain grouting in 64 dams with rationalization in Fig.3.

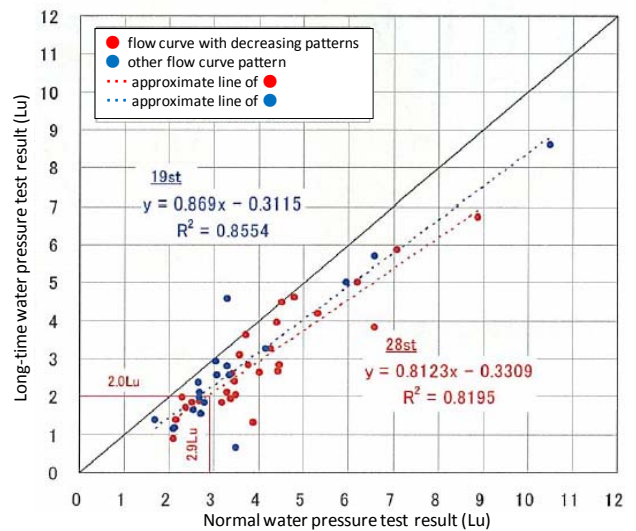
Long-time water pressure tests were conducted, and where the P-Q curve revealed a decreasing pattern of quantity in water pressure test in Fig.6, a Lugeon value of 2.9Lu in normal water pressure test was considered to correspond to less than 2.0Lu in long-time water pressure tests as shown in Fig.7. The improvement target Lugeon value was changed based on the results of Fig.7.

Figure 7. Comparison of Lugeon values between flow curves with decreasing patterns and other flow patterns

In the evaluation of final order holes, Lugeon values from 2.1 to 2.9 where the flow curves show decreasing patterns are evaluated as having reached the improvement target Lugeon value of 2Lu.
