Sediment Management through Tandem Operation of Dams in Kurobe River

Masanobu Takeuchi & Kenichi Sasaki

*Kurobe River Office, Ministry of Land, Infrastructure, Transport and Tourism, Japan
 takeuchi-m22ab@hrr.mlit.go.jp*

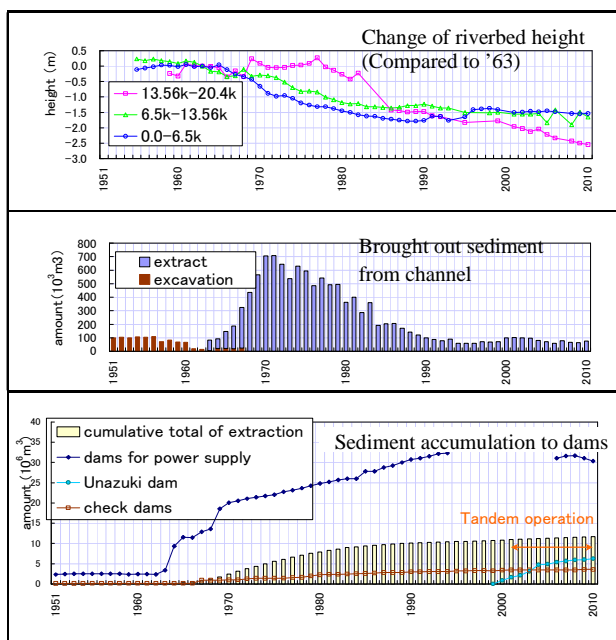
Figure 3. Sediment Balance in Kurobe River

accumulated to every kind of dams and is extracted from the channel (Fig.3), it is obvious that the extraction of sediment from channel has also great influence to the decrease of the outflow of sediment to the sea.

Total amount of checked sediment by dams in recent 6 decades is up to 30 million m³, while extracted amount is up to 12million m³ which includes excavated one. For the reduction of the influences of artificial activity, it was natural to be lead to the decrease of sediment extraction from the channel and the sediment discharge from dams. After the decrease of the excavation as public works, extraction of sediment began as commercial act, though it was expected its effectiveness for flood control. The amount of the extracted sediment was so much that the height of the riverbed has fallen down about 2m throughout the alluvial fan.

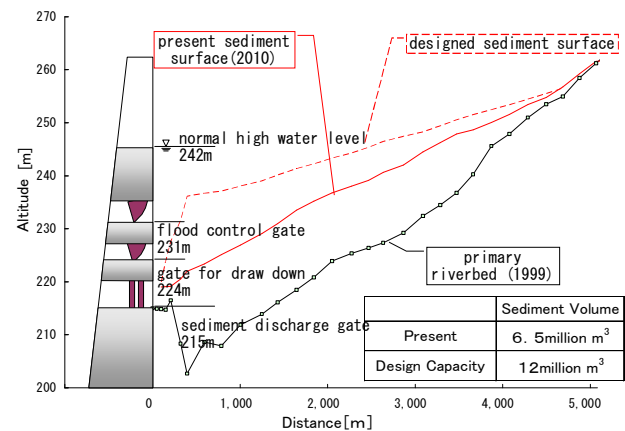
Figure 5. Longitudinal Cross Section of Unazuki Dam

Longitudinal cross section of river bed of Unazuki dam reservoir is shown in Fig.5. Even it has sediment discharge gate, accumulation of sediment to Unazuki dam has already reached 6.5 million m³ in 10 years. That is almost half of designed sedimentation.

Typical flood control dam has usually flat surface for sediment capacity. Since Unazuki dam has an aim of sediment discharge, expected river bed of reservoir has slope which is based on model experiment. Naturally, sediment surface would not be exactly the same to the result of it. Therefore, through the observation and measurement, it should be adequately monitored and some measures should be taken if necessary.

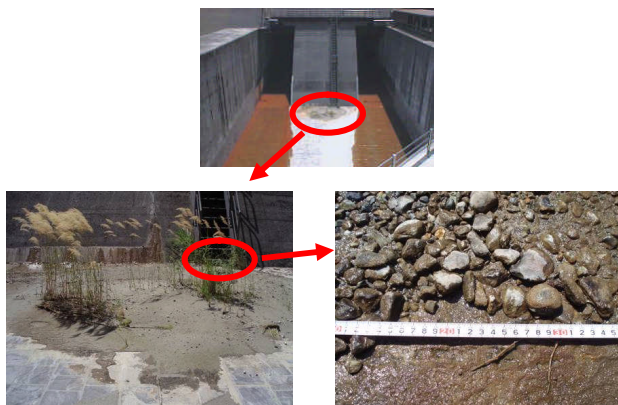
Figure 10. Remained Sediment at the Lower End of the Gate

Fig. 10 shows the remained sand at the lower end of sediment discharge gate of Unazuki dam. It can be seen that the diameter of the discharged sediment is maximum several centimetres.

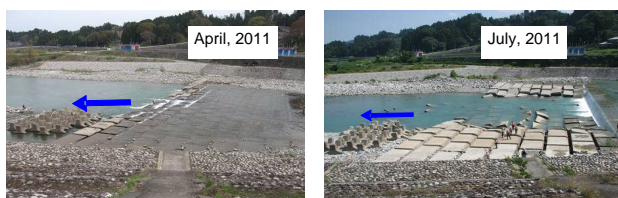
Figure 11. Destruction of the Ground Sill

Fig.11 shows the destruction of ground sill of the river, which locates at the top of the alluvial fan at 13.4k apart from the river mouth. Though the weight of each cubic

concrete block is about 60 tons, many of them were flashed. The cause of the damage was ascribed to the descent of the river bed which has fallen about 2 meters during a flood. For the prevention of this kind of damages, enough amount of sediment including cobbles should be supplied from the upper stream. However, it appeared that it might be difficult to discharge cobbles from Unazuki dam.
