DEVELOPMENT OF EMERGENT MONITORING SYSTEM FOR LEAKAGE FROM THE DAM

T Higuchi¹, T Sugai¹, T Sato¹, and T Kayukawa¹

1. IWAYA Dam Management Office, Japan Water Agency, Gifu, Japan

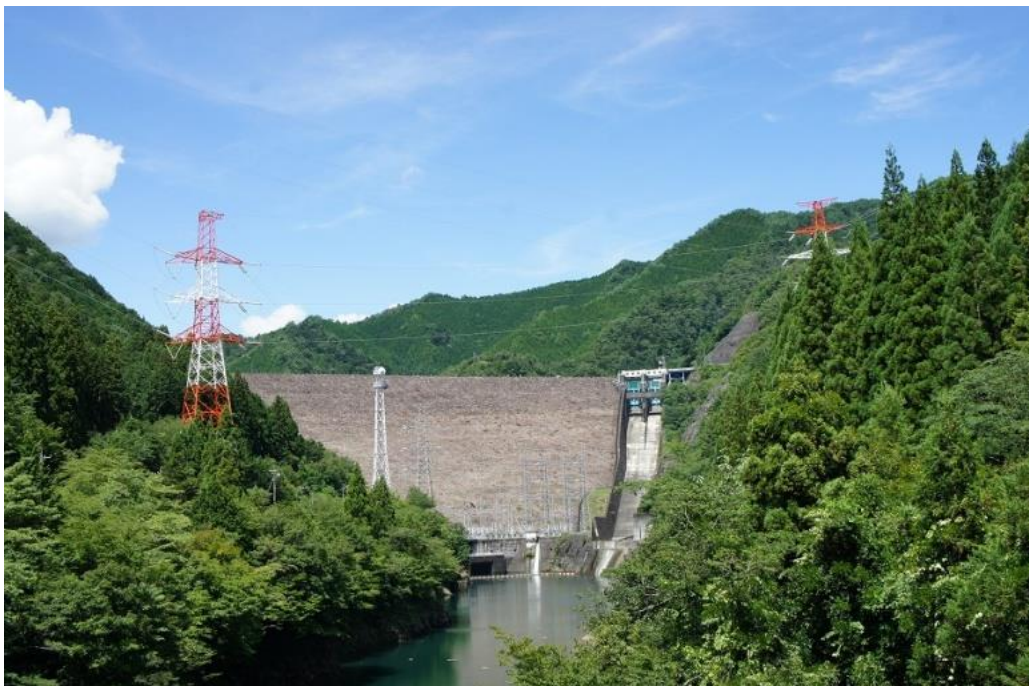
Figure 1. Downstream view of the IWAYA Dam

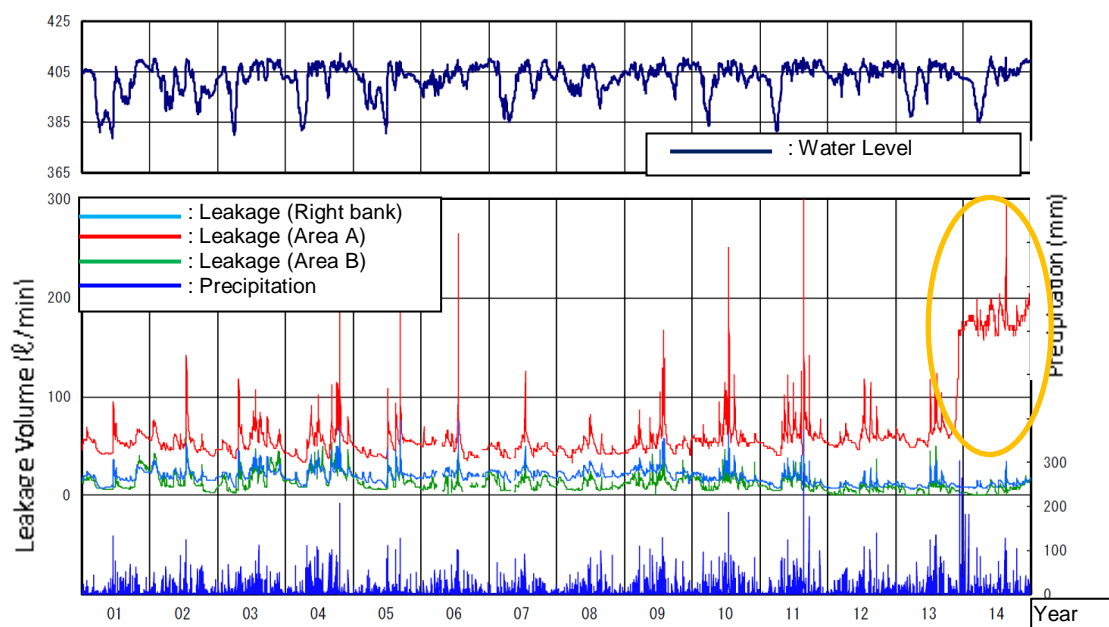
Figure 2. Leakage value of the IWAWA Dam

Monitoring leakage from the dam body and its shallow foundation is one of the important factors in order to grasp the status of rock-fill dams. The IWAWA Dam has been equipped with monitoring system for leakage volume since its construction. The volume of leakage from the dam body and its shallow foundation had recorded stable value of approximately 75 l/min for a long time. From the middle of November to early December in 2013, the volume of leakage had been increasing gradually, its value recorded approximately 170 l/min. As a result, the IWAWA Dam Management Office took 24-hour alert condition in preparation for unexpected increasing leakage from the dam body and its shallow foundation. The initial monitoring system for leakage volume was equipped only on-site alert function that meant officers needed to stay in the machine room at the management office throughout a day in order to monitor leakage and its alert. (see Figure 2) The number of officers of the IWAWA Dam Management Office was limited, as a result, many JWA officers from other offices were dispatched for the monitoring.
