Experimental study of ski jump spillway at the Nam Ngiep1 Hydropower Project in Laos

The Nam Ngiep 1 Hydropower Project in Laos is under construction: two dams and two powerhouses with total installed capacity of 290MW. A 167 m roller compacted (RCC) dam is being constructed in the narrow valley and will be equipped with a ski jump spillway with multiple flip bucket. Hydraulic model tests have been carried out in order to confirm the effect of deflectors and alternative flip bucket geometries which promote increased longitudinal dispersion of the water jets and diving zones downstream in the river course.

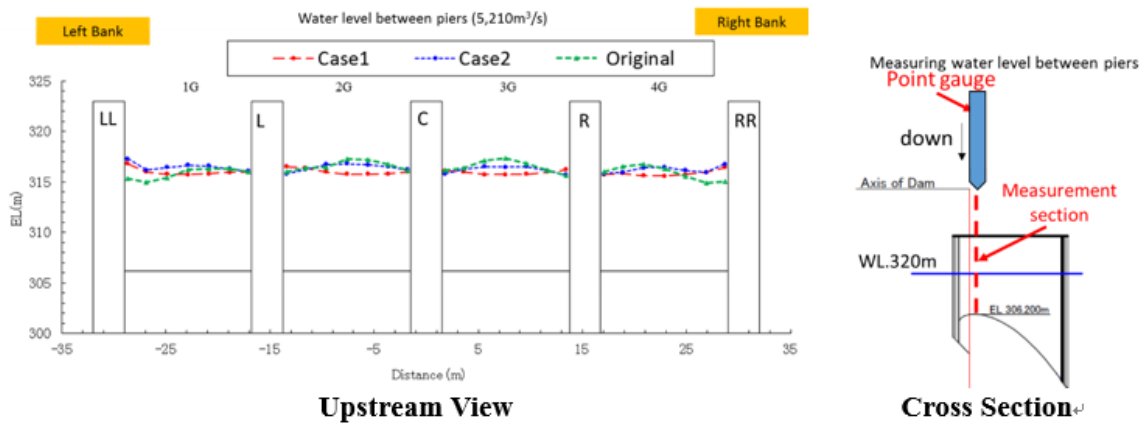
Figure 14. Effect of Pier Extension Upstream

Difference between Maximum Water Level and Minimum Water Level (m)

Standard Deviation of Water Level (m)

The tests were conducted under the designed flood of $5,210 \text{ m}^3/\text{s}$, and the water level data at the approach between each pier was measured by point gauges. The imbalance of the water level in both cases was rectified to a flat line, though they still fluctuated slightly, and the shock wave disappeared as shown in Figure 14. There was no significant difference in the degree of improvement between Case 1 and 2.
